# Investigation of H<sub>2</sub>S Gas Release Platform Hermosa, OCS-P 0316 Pacific OCS Region

August 3, 1999

U.S. Department of the Interior  
Minerals Management Service  
Pacific OCS Region

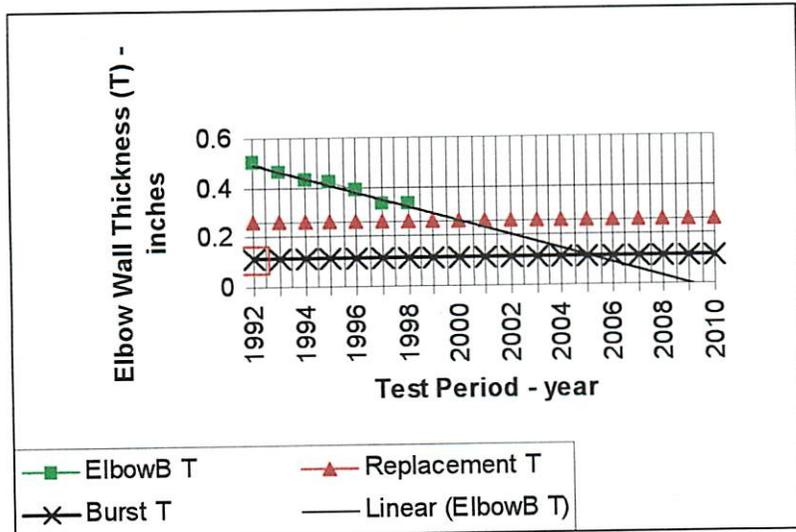
Figure 1. Elbow Thickness Upstream of Rupture.

It is common practice among all Pacific OCS Region facility operators to use the A-scan UT to spot check wall thickness at predetermined points along process piping (e.g., every second or third fitting and pipe length). Chevron followed this commonly used practice, but the elbow that failed was never tested. The wall thickness of the ruptured elbow was nearly half the thickness reading found on the elbows just upstream and downstream of the failure.

Using criteria A above and the UT data collected by Chevron from 1992 to 1998, the piping at Platform Hermosa was graphed. These graphs, shown in Figures 1 and 2 on the following page, use data collected immediately before and after the ruptured elbow. The trend lines, identified in the legend as "linear (Elbow T)," project that at the current rate of corrosion upstream of the ruptured elbow, the piping would reach its replacement thickness, 0.026 inch, in the year 2000 and would burst in the year 2005 if left unchecked (Figure 1). Figure 2 shows that the portion downstream of the ruptured elbow would reach its replacement thickness in 2005 and would not reach the burst thickness until after 2010.

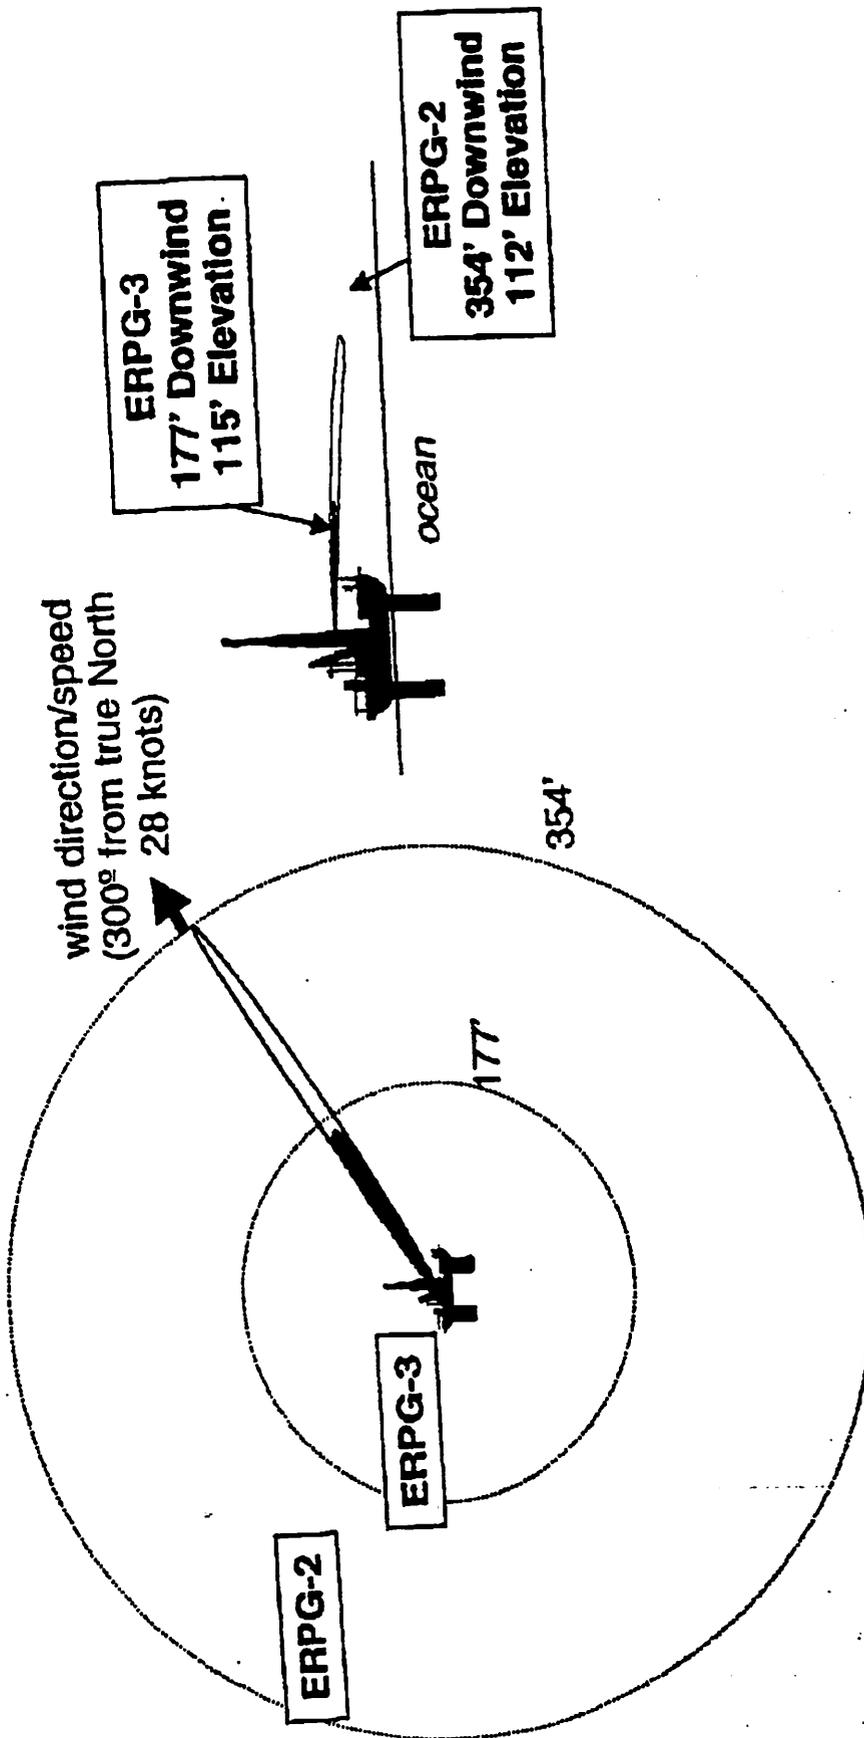
Figure 1 H<sub>2</sub>S Toxic Hazard Footprints for Point Arguello Offshore Gas Release on August 3, 1999

Results of the consequence modeling are presented in Table 2. Figure 1 shows a plot of the H<sub>2</sub>S toxic hazard zones. These results indicate that hydrogen sulfide concentrations exceeding the ERPG-3 level, which could be life threatening, would be limited to the vicinity around the platform with the hazard zone extending approximately 177 feet (53.9 meters) from the platform. The hazard zone would have had a maximum width of approximately 13 feet (3.9 meters). At the farthest downwind distance the plume would have been approximately 115 feet (35 meters) above the water level. Therefore, the H<sub>2</sub>S toxic cloud would not have represented a hazard to boaters in the area.

Potential serious injuries, as represented by the ERPG-2 level, would also be limited to an area near the platform. The ERPG-2 hazard would extend approximately 354 feet (108 meters) from the platform. The hazard zone would have had a maximum width of approximately 31 feet (9.4 meters). At the farthest downwind distance the plume would have been approximately 112 feet (34 meters) above the water level. Therefore, the H<sub>2</sub>S toxic cloud would not have represented a hazard to boaters in the area.

The flammable hazard zone would have extended to a downwind distance of approximately 179 feet (54.6 meters). The flammable hazard zone would have had a maximum width of approximately 16 feet (5 meters). At the farthest downwind distance the plume would have been approximately 115 feet (35 meters) above the water level. Therefore, the flammable cloud would not have represented a hazard to boaters in the area.

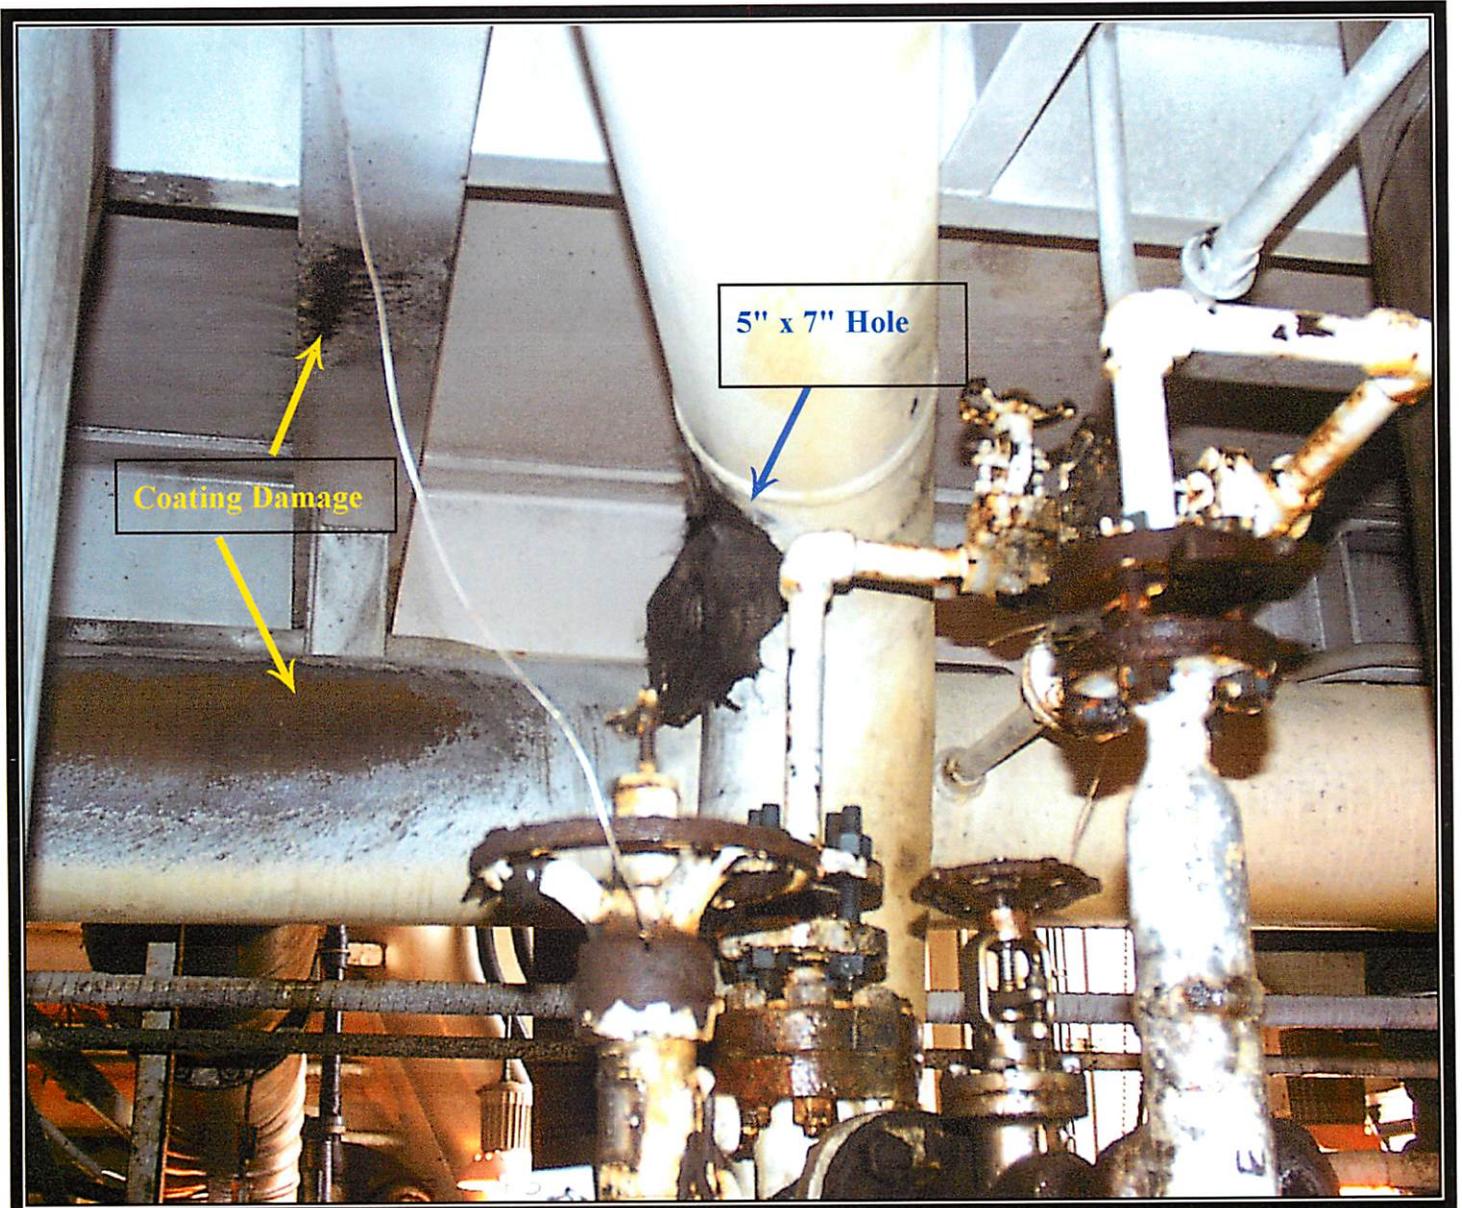
Appendix A.5-Ruptured Elbow and Surrounding Damage

The flowline failed due to internal corrosion, which reduced the wall thickness until it could no longer support the normal operating pressure. Corrosion was caused by condensed liquid water reacting with H<sub>2</sub>S gas to form a corrosive acid gas.

The original nominal wall thickness of the flowline was 0.50 inch. The thickness at the rupture was 0.14 inch. Per ASME B31.3, the minimum allowable operating thickness for 1209 psi is 0.26 inch and the burst thickness is 0.11 inch.

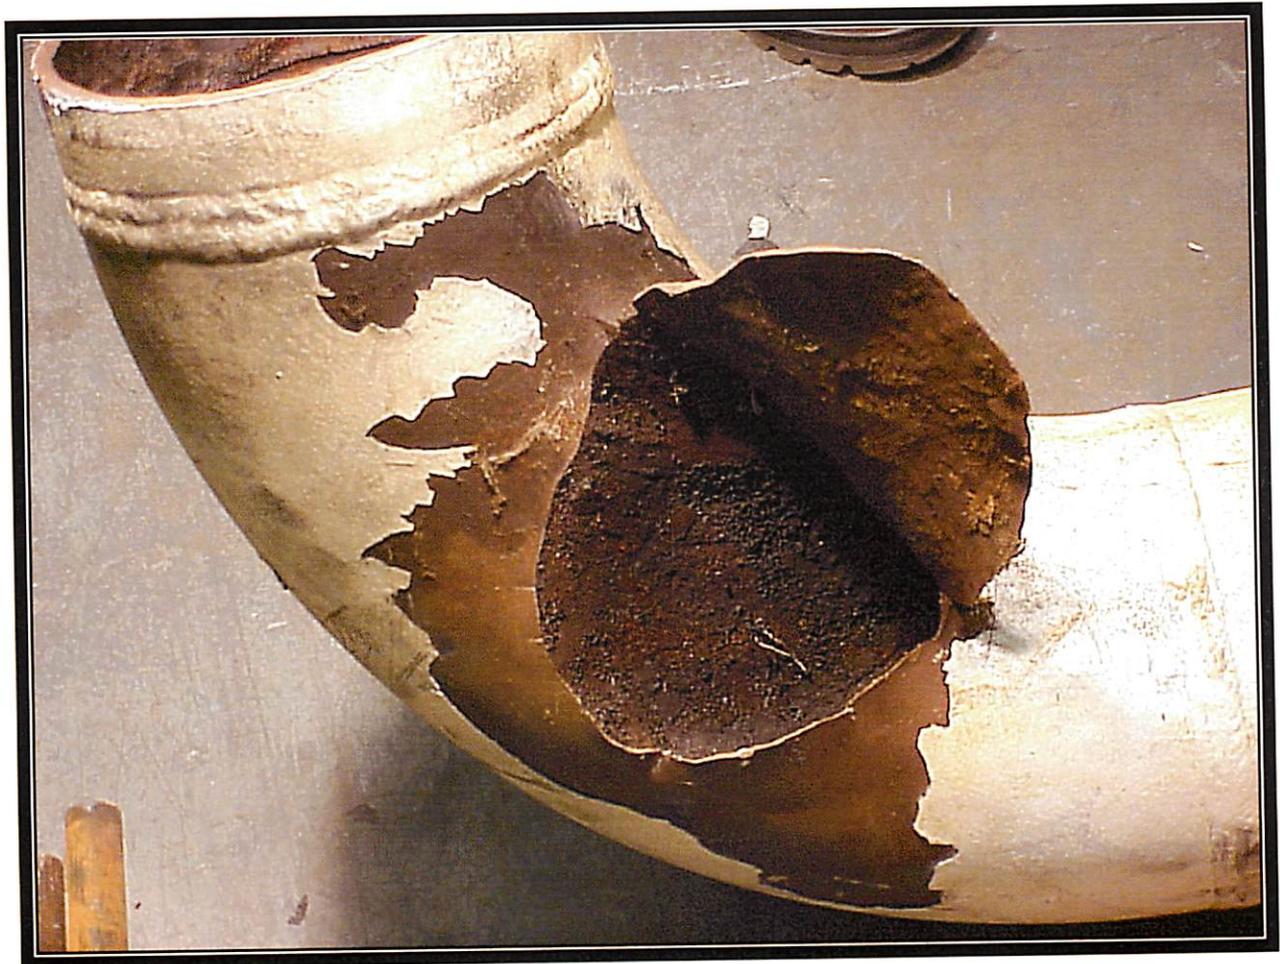
Appendix A.6-Ruptured Elbow

After extensive review of the circumstances of the incident, along with Chevron's root cause analysis and metallurgical analysis, the Team finds it is clear that the elbow failure was caused by acid gas corrosion (i.e., H<sub>2</sub>S dissolved in condensed water). The elbow's wall thickness was insufficient to hold the normal operating pressure and ruptured.

The heavy FeS scale deposition upstream of the failure location is a by-product of the corrosion occurring in the flowline. Chevron believes that similar scale also existed in the failed elbow, but was dislodged by the force of the rupture.

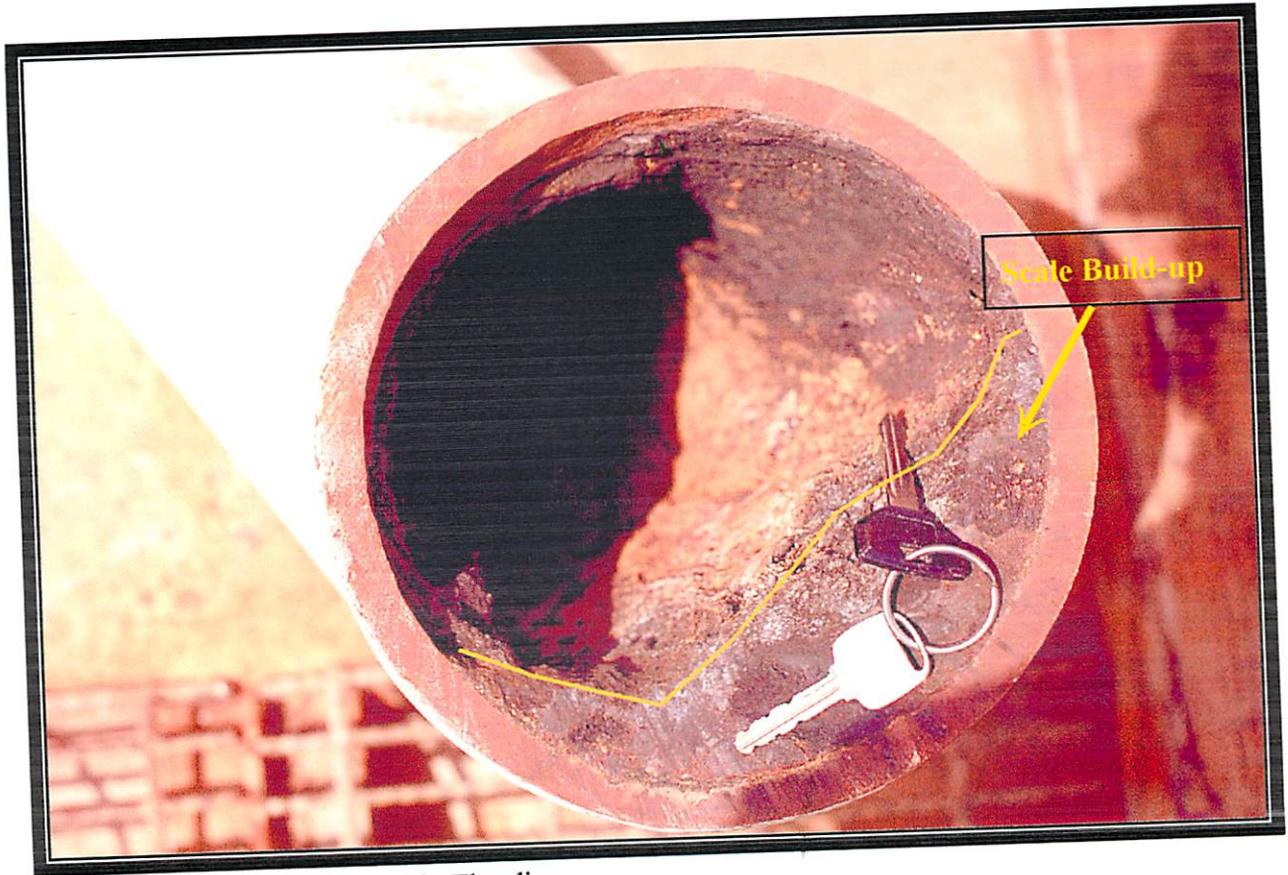
Appendix A.8-Scale Build-up in Flowline

The results of the scale analysis confirm that H<sub>2</sub>S was responsible for the corrosion. In three of the four scale samples analyzed, the XRD showed major iron sulfide (FeS) present with minor FeS present in the fourth sample. The FeS is a by-product of corrosion occurring in the flowline ( $\text{Fe} + 2\text{H}_2\text{S} \Rightarrow \text{FeS} + 2\text{H}_2$ ).
