## EROSIONAL/CORROSIONAL TESTING FOR MULTIPHASE FLOW LINES

FINAL REPORT  
SwRI Project No. 04-6461

For  
Minerals Management Service  
U.S. Department of the Interior  
Reston, Virginia

April 1995

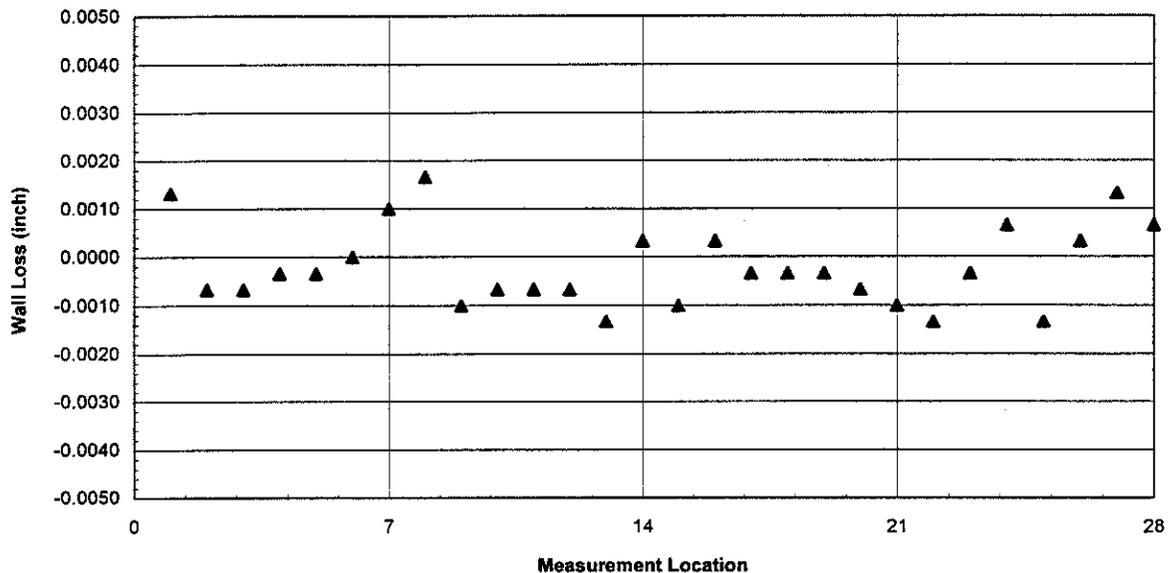
During each test, the general pipe wall loss was determined using ultrasonic wall thickness measurements. Measurements were taken along the outside bend of each elbow at seven locations (15°, 25°, 35°, 45°, 55°, 65°, 75° from the inlet plane of the elbow). This location was chosen because it is where the highest wear would be expected (it is located where the liquid impinges on the elbow bend). No general wall loss was recorded during any of the tests (only localized pitting wear was seen). An example of the wall loss measurements for Test 7 is shown in Figure 3.3. The wall thickness measurements were repeatable to about  $\pm 0.002$  in., so wall loss measurements less than this amount are not significant. For comparison, if the bare metal corrosion rate of 100 mpy were maintained (by removal of the corrosion product film by the two-phase flow stream) for a period of 30 days, the wall loss would be about 0.008 inch. Since this amount of wear would be measurable with the ultrasonic probe, the protective corrosion product film prevented general wall loss.

**Figure 3.3. Wall Loss Measured in the Elbows During Test 7. Seven measurements were made in each of the four elbows.**

*Test 7* was conducted with a gas superficial velocity of 15 ft/sec and a liquid superficial velocity of 0.8 ft/sec. The flow was in the slug flow regime. The test ran for a period of 35 days. The ultrasonic wall thickness measurements taken during the test showed no general wall loss during the test. No pitting or general wear was found in the straight sections of pipe. One of the test fittings did not have any pitting, but the other three had some pitting. One of the fittings had a number of small pits located along the outside bend of the elbow between 40° and 60° from the elbow inlet (inlet plane is 0° and exit plane is 90° degrees) and located in a 1 in. diameter region that was centered slightly above the centerline of the pipe. The pits were very shallow and irregularly shaped. The pit diameters were typically about 0.01 in., and the pit depth was about 0.005 inch. The second elbow experienced pitting in a 0.4-in.-diameter region located 60° from the elbow inlet and centered 0.3 in. above the pipe centerline. The largest pit was about 0.07 in. in diameter and 0.008 in. deep. The second largest pit was 0.01 in. in diameter, but deeper (0.020 in.). The third elbow had a rough surface texture in a 0.4-in.-diameter region located 55° degrees from the elbow inlet and centered slightly below the centerline of the pipe. The attack was very shallow (less than 0.005 in. deep) and appeared more like a removal of the corrosion product film (leaving islands where the film remained) than pitting.

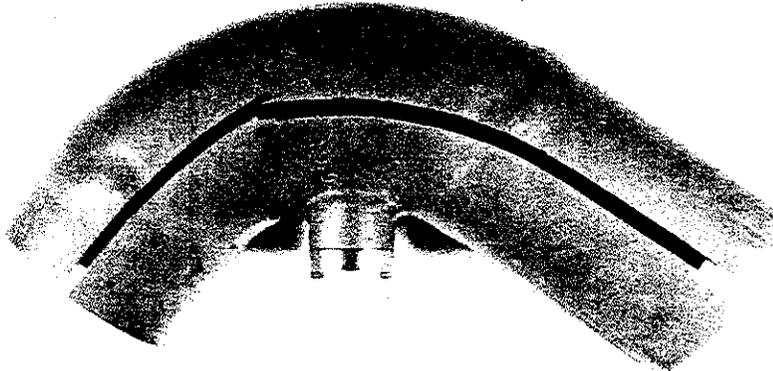
**Figure 3.6. Photographs of Test Fitting. The top figure shows the test fitting cut open for inspection. The bottom figure shows the pitting wear experienced during Test 9. The view is of the inside surface of the elbow near the three flaws that were machined into the elbow.**

*Test 9* was conducted with a gas superficial velocity of 36 ft/sec and a liquid superficial velocity of 0.36 ft/sec. These test conditions resulted in stratified wavy two-phase flow. The test ran for 36 days. The ultrasonic wall thickness measurement showed that no general wall loss occurred during the test. Inspection of the test fittings after completion of the test showed no localized pitting wear in the straight sections of pipe and no pitting wear in three of the four test fittings (the long radius 90° elbows). One of the fittings showed some pitting located in the upper half of the elbow at the location where drops flowing straight down the pipe would impinge on the surface of the elbow. The largest pit was 0.024 in. in diameter and 0.015 in. deep. The second largest pit was 0.020 in. diameter and 0.012 in. deep. The rest of the pits were less than 0.010 in. in diameter.

Most of the corrosion pits appeared to be passivated (no longer actively growing). The exceptions were the two largest pits, which appeared to be active. The bottoms of these pits were not covered with a protective corrosion product film. Since some of the fittings experienced pitting and some did not, it appears the test may have been conducted near the upper limit of an acceptable operating velocity.

<b>LARGEST PITS FOR EROSION/CORROSION TEST 9</b>		
<b><u>Test Fitting</u></b>	<b><u>Pit Diameter (mils)</u></b>	<b><u>Pit Depth (mils)</u></b>
Elbow #1	24	15
Elbow #2	None	
Elbow #3	None	
Elbow #4	None
