NIPTERK P-32 SPRAY ICE ISLAND

ABLATION PROTECTION EXPERIMENT

J.P. POPLIN

JANUARY 1990

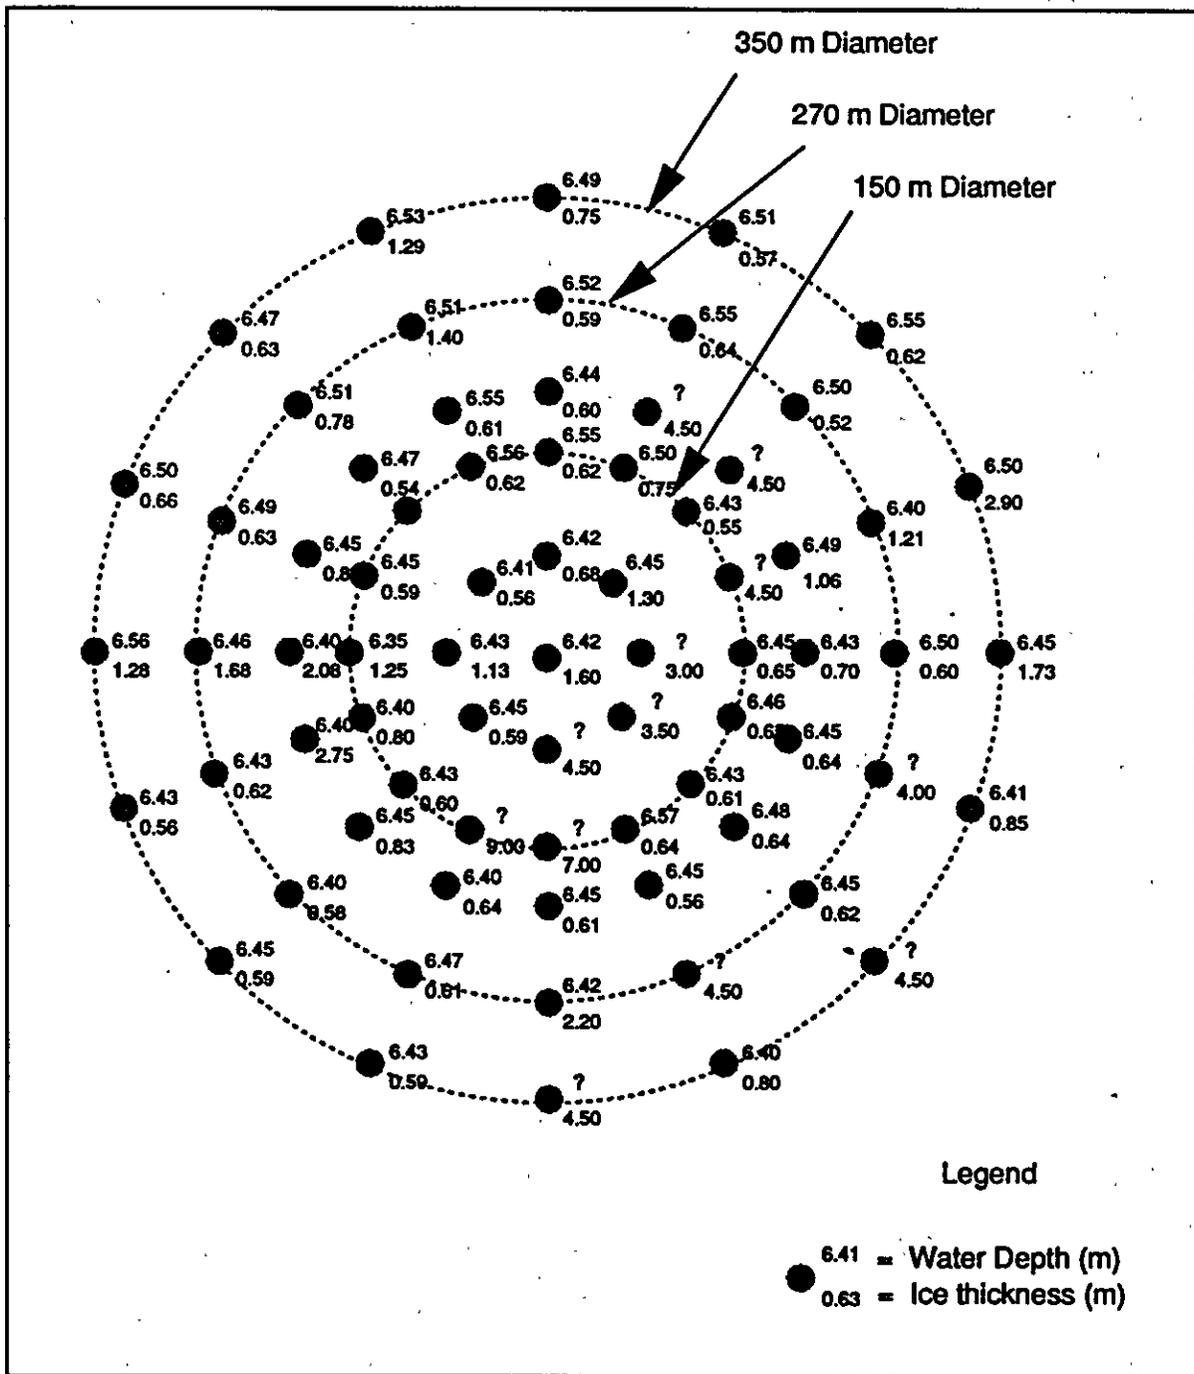
Figure 2. Site Bathymetry and Initial Ice Thicknesses as Measured in Mid-November, 1988.

Bathymetry was measured at the site prior to island construction and found to average 6.5 m with a range of 6.38 to 6.65 m, inclusive. A map showing water depth measurements at the site is presented as Figure 2. Included in the figure are ice thicknesses measured in mid-November. Note that the first-year ice sheet was rubbled and rafted.

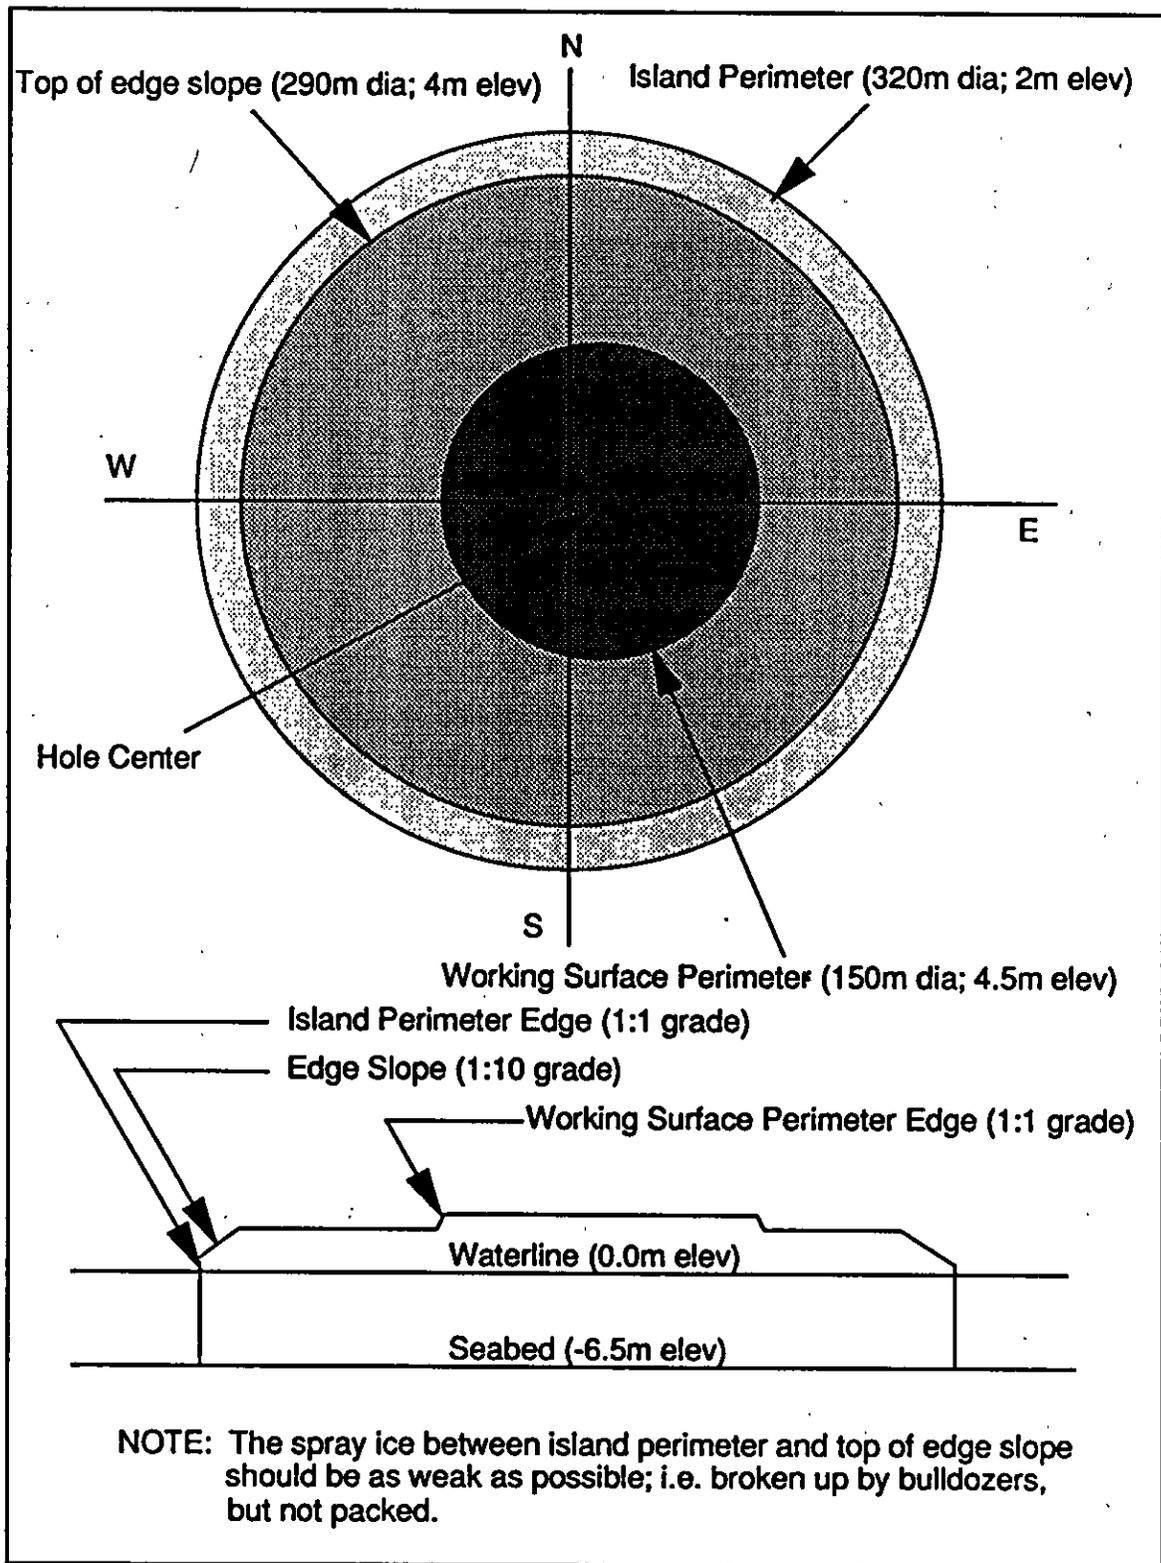
Figure 3. Island Design Geometry

A diagram showing the island design geometry is presented as Figure 3. Several environmental conditions necessitated that the design of Nipterk be different than previously constructed spray ice islands. First, Nipterk was built at a more exposed location. Second, the seabed soils were relatively weak which necessitated that the size of the island be greater. Third, due to its proximity to the MacKenzie River, source water used to construct the island was essentially fresh, resulting in warmer underwater spray ice.

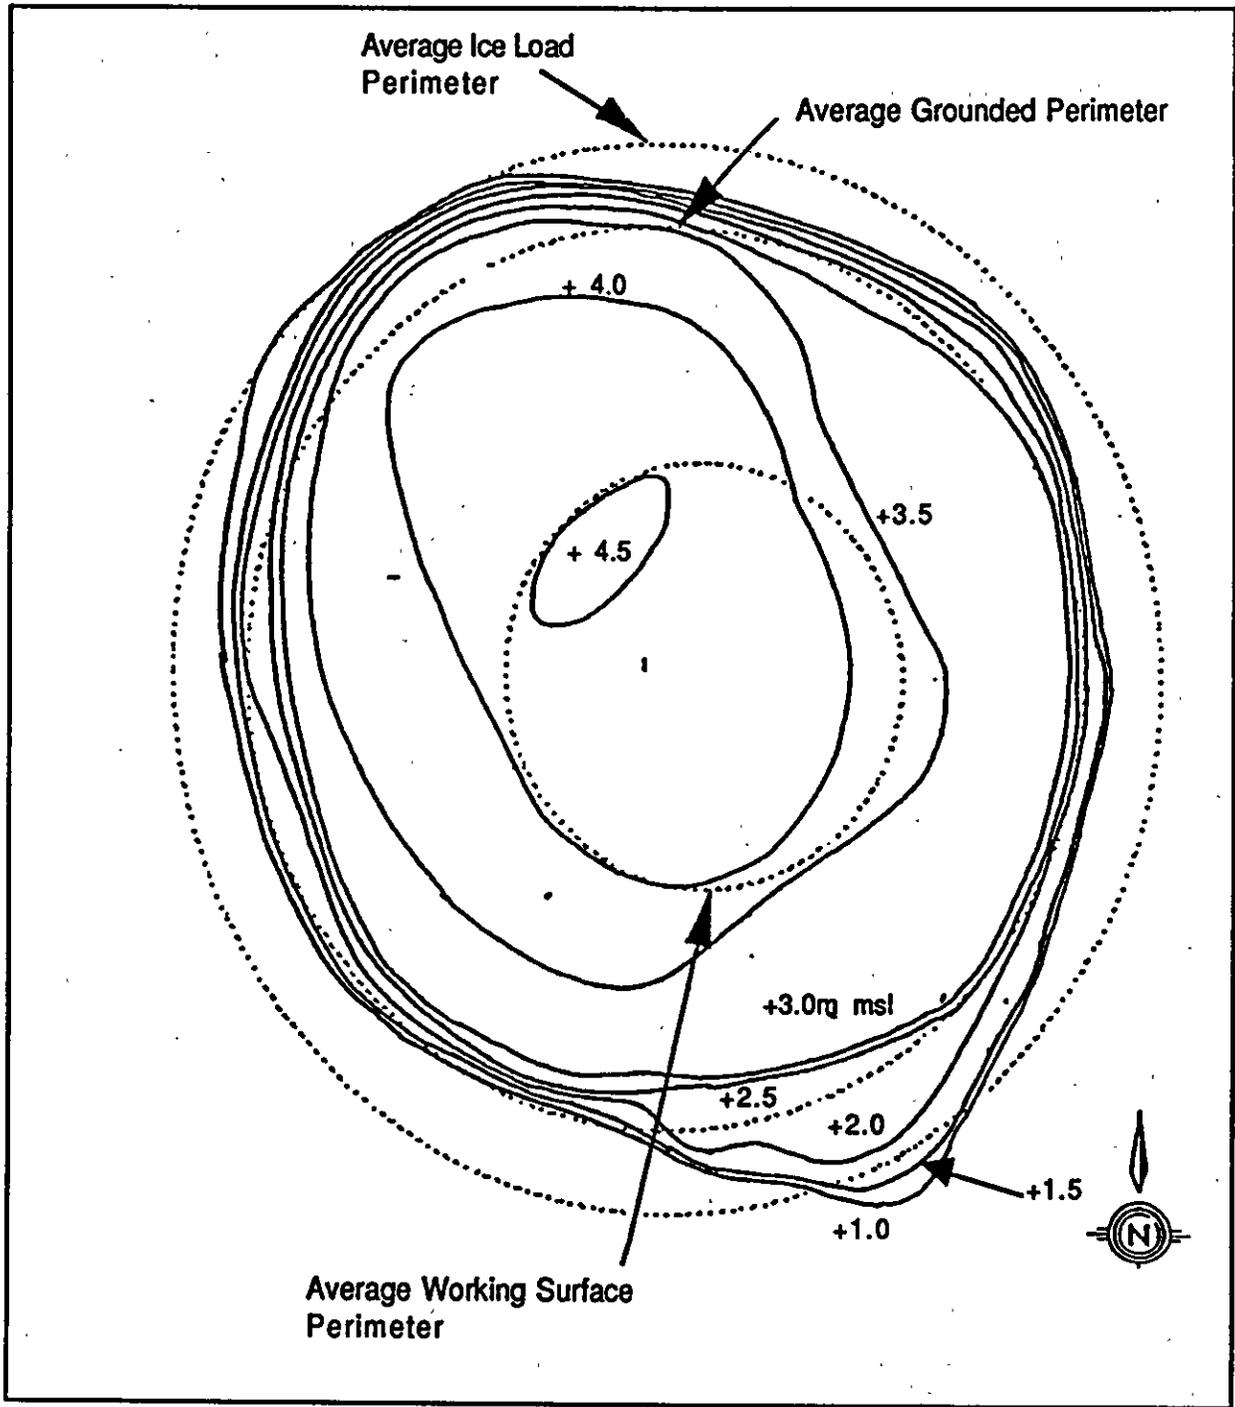
Figure 4. As-Built Contour Map of Island

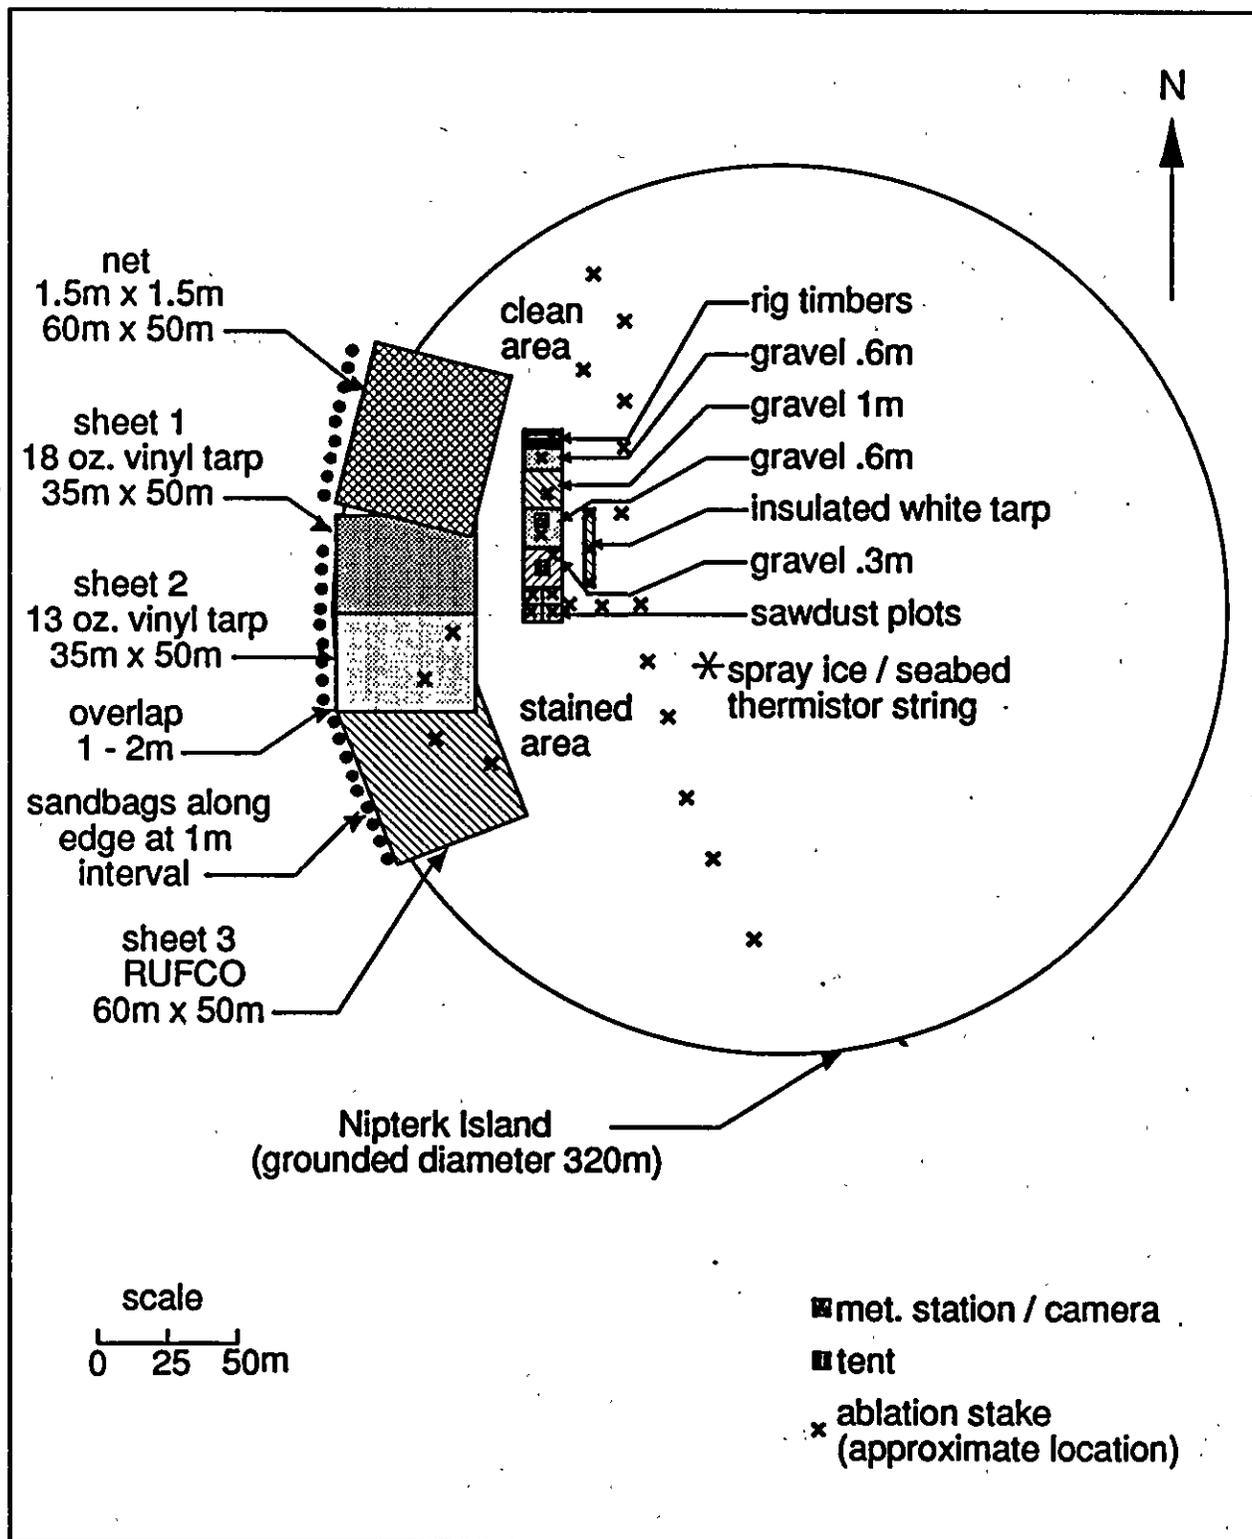
Figure 5. Island Protection System and Ablation Plot Layouts

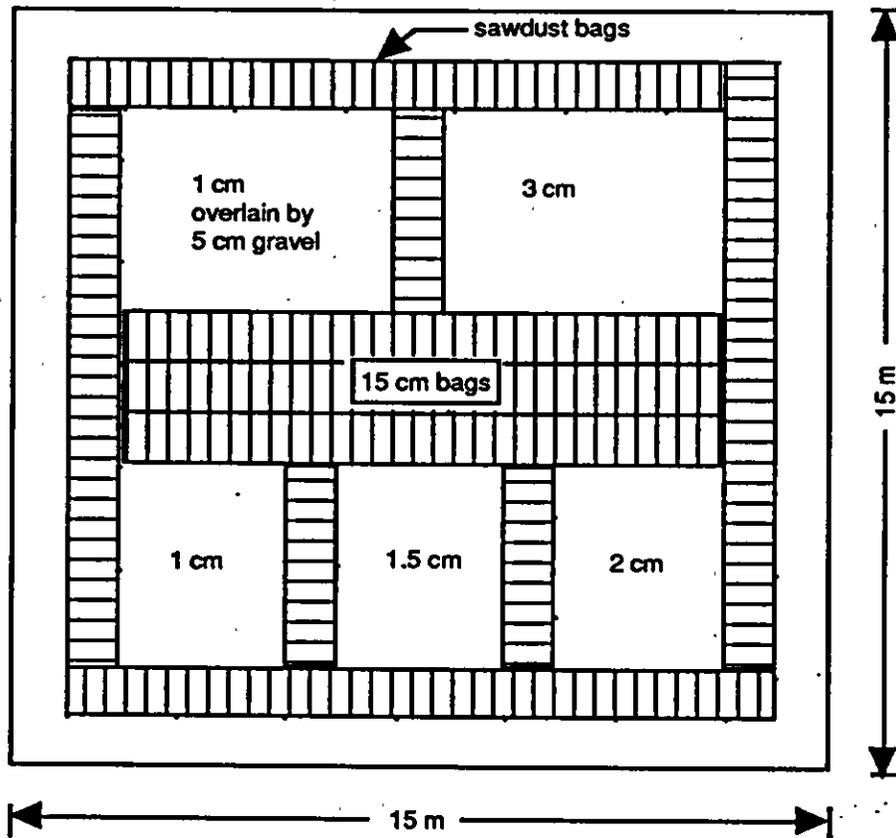
Figure 6. Layout of Sawdust Ablation Test Plots

A 15 m by 15 m sawdust ablation plot was constructed by hand using four pallet boxes of sawdust available from the drilling program. A number of subplots were created (see Fig. 6) to evaluate the degree of surface ablation protection afforded by

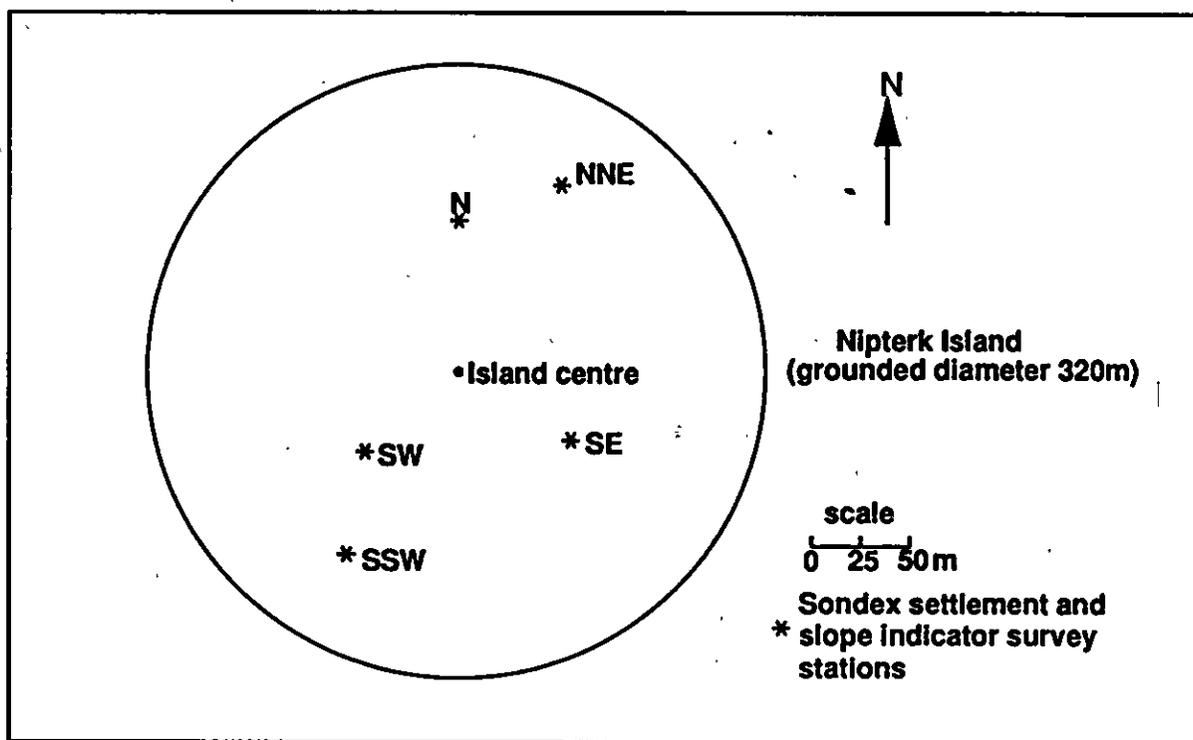
Figure 7. Locations of Sondex Settlement and Slope Indicator Survey Stations

Finally, the five Sondex settlement and slope indicator stations originally installed in January were left in place so that measurements could be continued. Locations of these stations are shown in Figure 7. Initial (baseline) settlement and inclinometer surveys were performed on April 22.

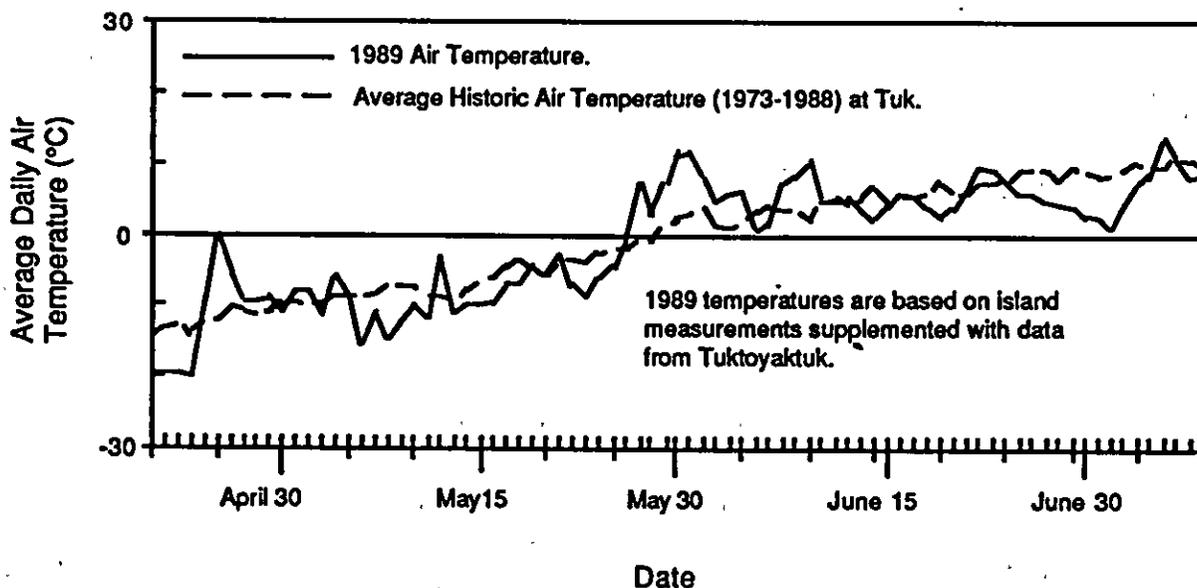
Figure 9. Comparison of 1989 and Historical Air Temperatures

Figure 9 is a plot of average daily air temperature. The data set utilizes air temperatures measured on the island whenever they are available. Prior to landfast ice sheet breakup, air temperatures measured on the island were generally similar to those observed in Tuk. Following breakup, island air temperatures were usually less than those recorded in Tuk due to the influence of the water and in some cases ice near the island. Another factor which contributed to the differences observed between Tuk and island measured air temperatures is that the island was not subjected to the the degree of warming experienced at Tuk as a result of land-derived winds due to its distance offshore.

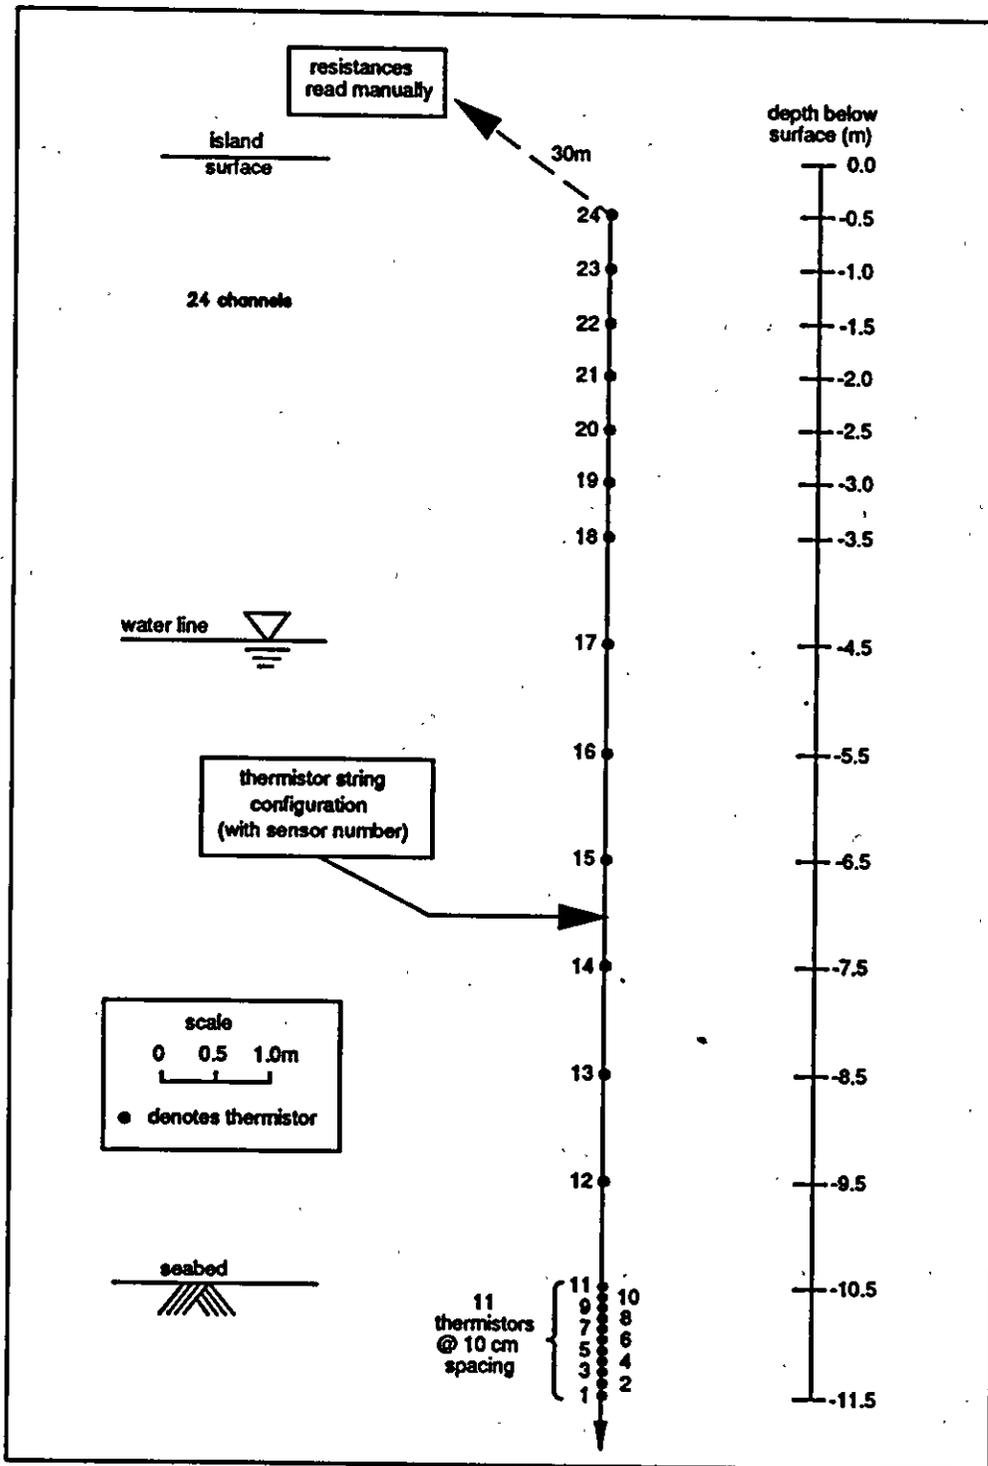
Figure 10. Configuration of Spray Ice/Seabed Thermistor String

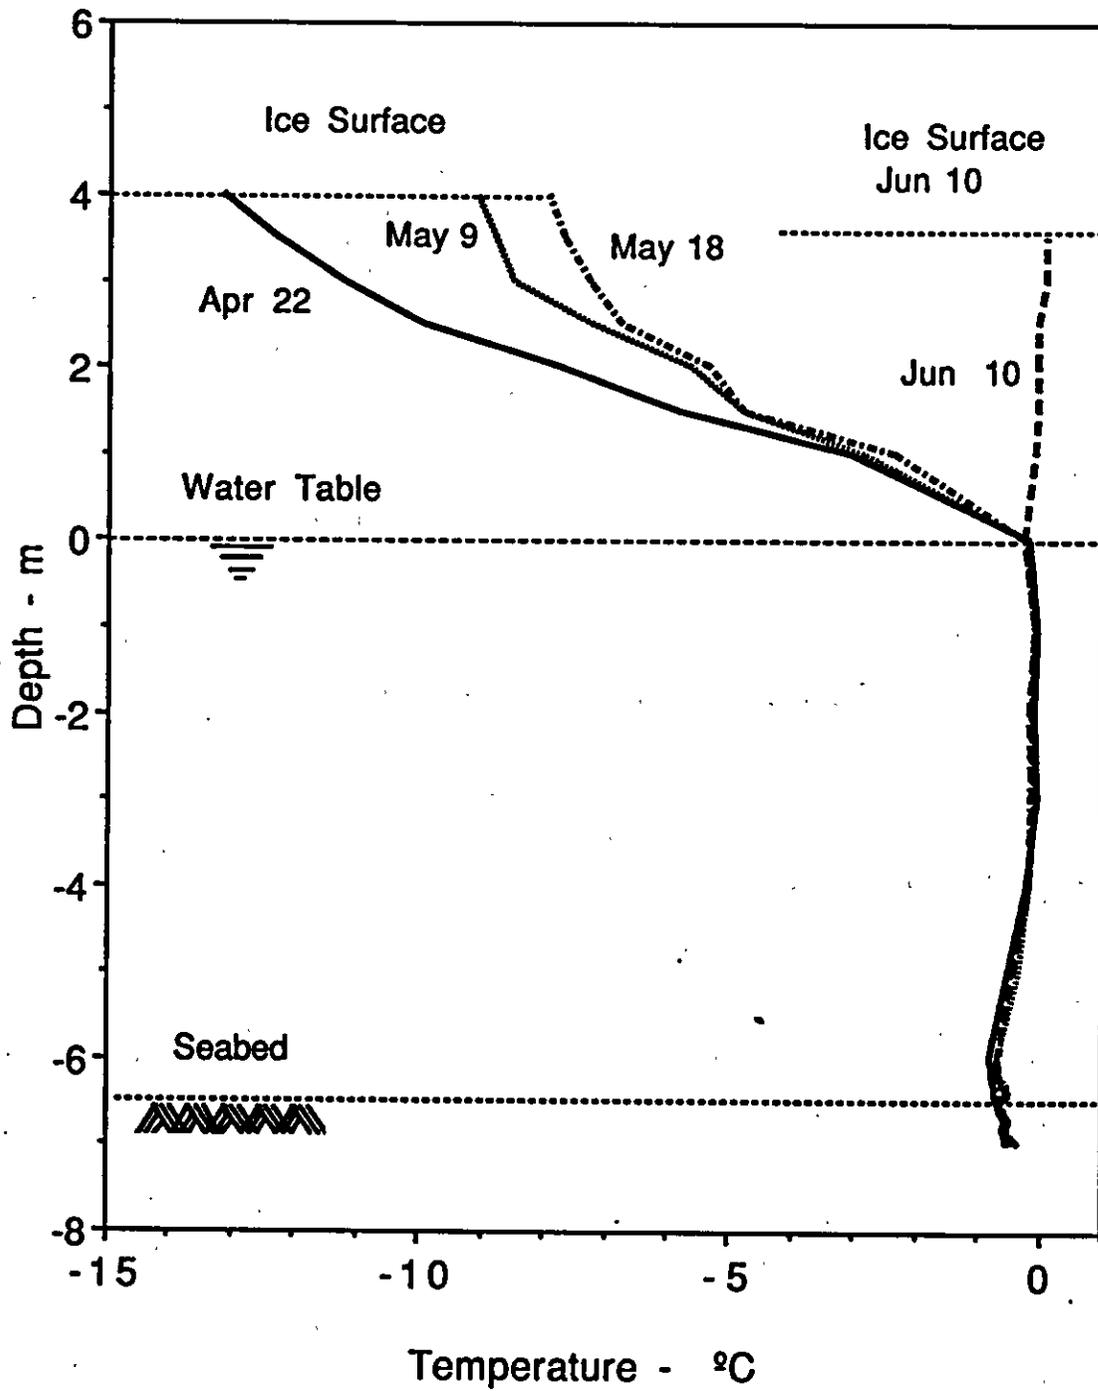
Figure 11. Spray Ice/Seabed Temperature Profiles

Thermistor resistance readings were taken on April 22, May 9, May 18, June 10, and June 22 (Appendix B). Temperature profiles (for all but June 22) are shown in Figure 11. The abscissa represents ice temperature in degrees Celsius and the ordinate represents the depth in meters measured from the ice surface at the time

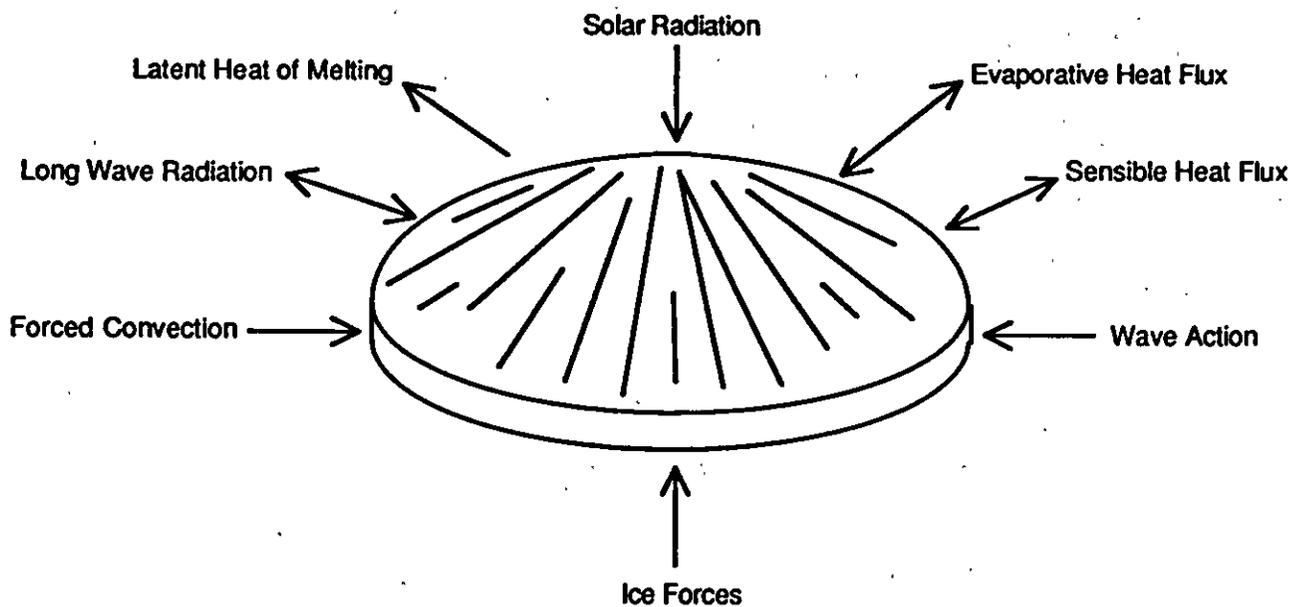
Figure 12. Energy Transfer Parameters. From Connolly [1].

Albedo is defined as the ratio of reflected to incident shortwave radiation. Spray ice albedo decreases after construction and as the melt season progresses due to the accumulation of dust and debris on the surface, largely from the drilling operation. However, the addition of foreign materials on the island surface does

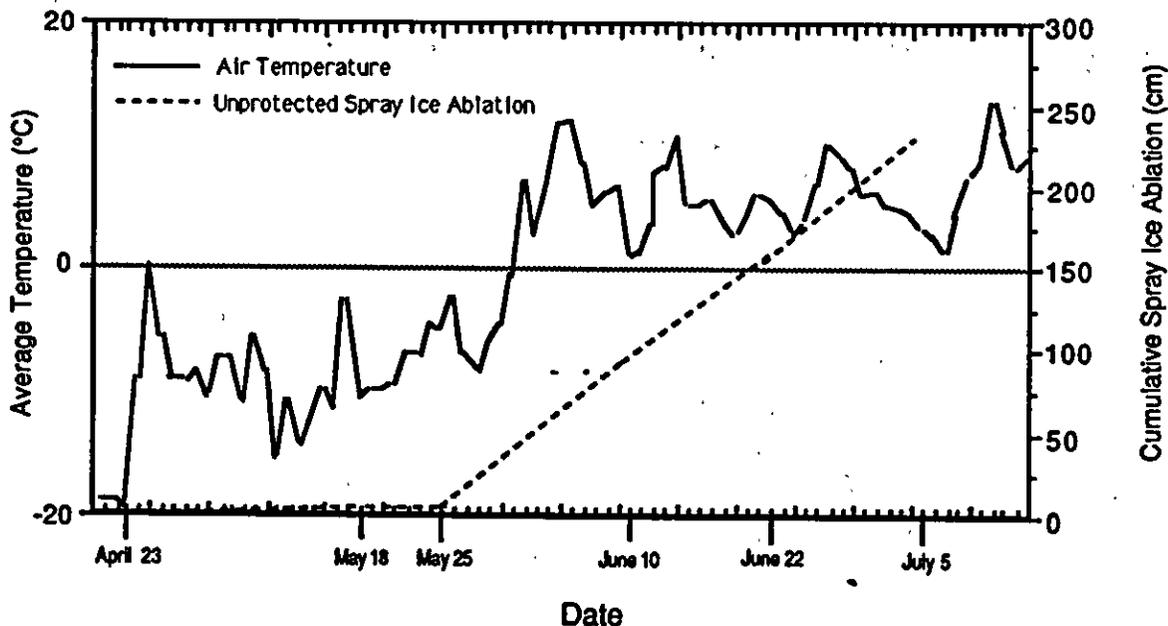
Figure 13. Cumulative Ablation of Unprotected Spray Ice

Average cumulative surface ablation of the unprotected spray ice (in centimeters) as a function of time is plotted in Figure 13. Individual ablation stake measurements are provided in Appendix C. Ablation was computed from measurements at 15 unprotected spray ice survey stake locations. Also shown are the average daily temperatures for the study period.

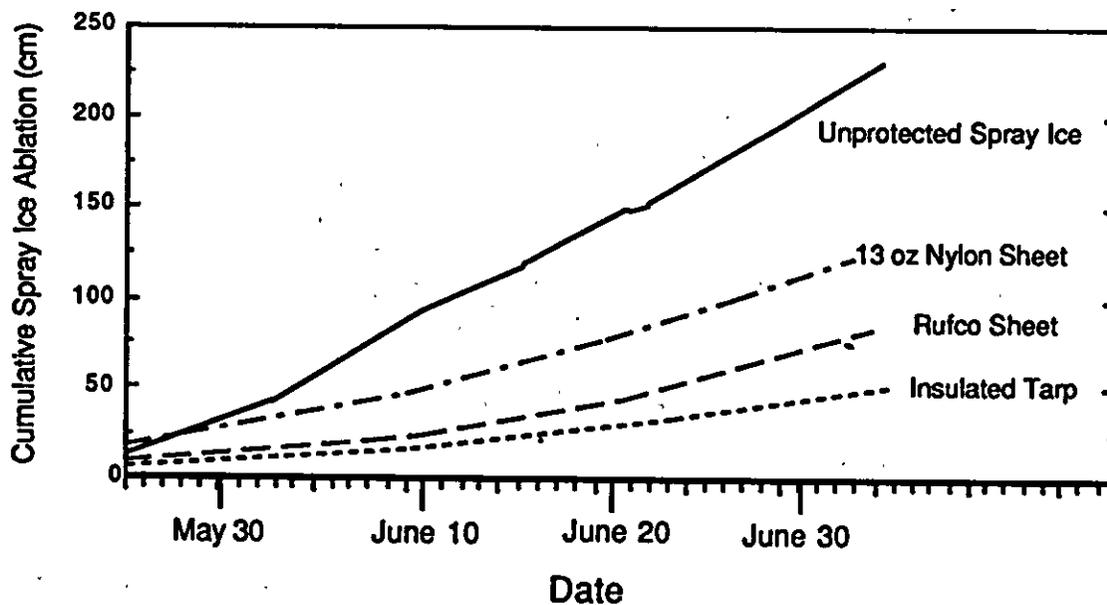
Figure 14. Sheet/Tarp Ablation Mitigation Comparisons

The effectiveness of the sheets and insulated tarpaulin in protecting the spray ice is demonstrated in Figure 14 which compares cumulative spray ice ablation with time. Surface ablation of the unprotected spray ice is also shown. Both the 13 oz. nylon sheet and the Rufco sheet had the effect of cutting the ablation rate by about one-half that measured for unprotected spray ice. The insulated tarpaulin further enhanced protection of the spray ice. Over the course of the measurement period, the average cumulative ablation was only 0.5 m, compared to 0.85 m for the Rufco sheet and 1.25 m for the vinyl sheet. The ablation reduction benefits afforded by the sheets are attributed to a combination of their relatively high albedo and the insulating effects provided by the entrapped air layer between the surface of the ice and the sheet.

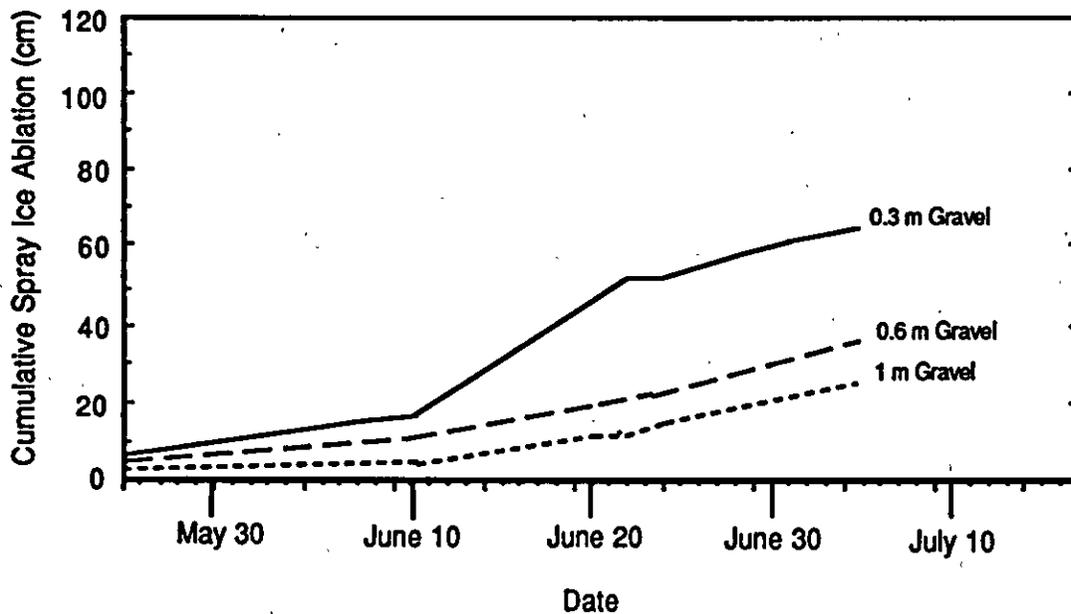
Figure 16. Gravel Ablation Test Plot Comparisons

Cumulative spray ice ablation associated with the 0.3 m thick gravel cover totaled 65 cm. This magnitude of ablation was similar to that recorded for an equivalent

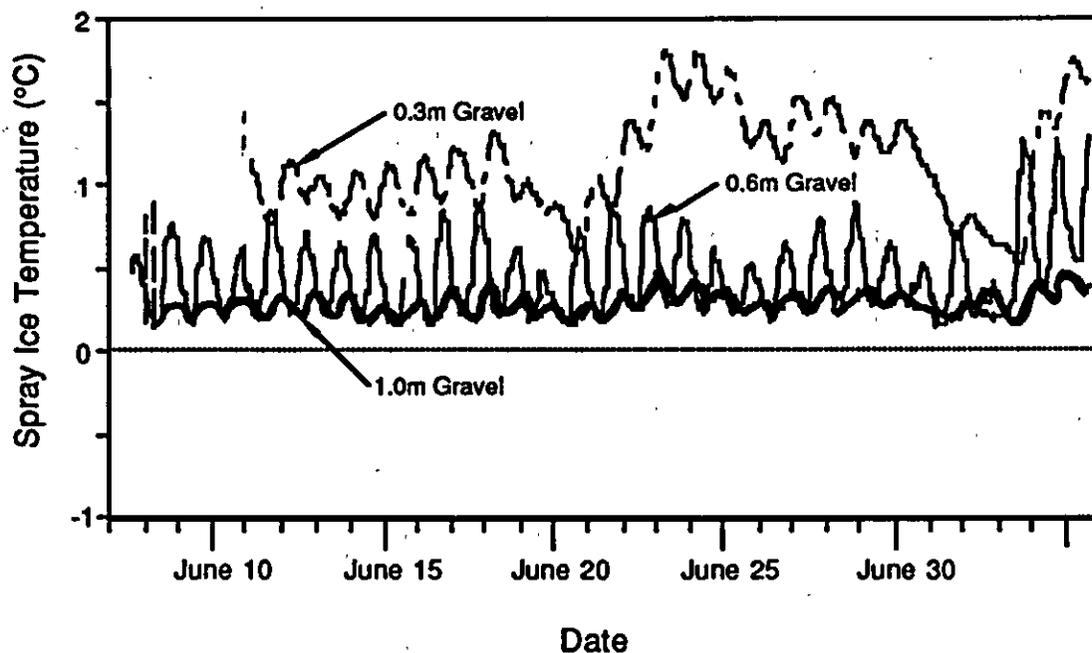
Figure 18. Spray Ice Temperatures Beneath Gravel Plots

Figure 18 is a time series plot of surface spray ice temperature measurements collected beneath the gravel ablation plots. Also included in the figure are averaged daily air temperatures recorded on the island during the same period. One can see from the figure that a 1 m thickness of gravel offered the best degree of insulation, limiting the average temperature to about 0.3°C throughout most of the measurement period. Minimal fluctuation from day to day is documented, except in early July where a slight warming trend is observed. Similarly, average spray ice temperature data from the 0.6 m thick gravel ablation plot show the

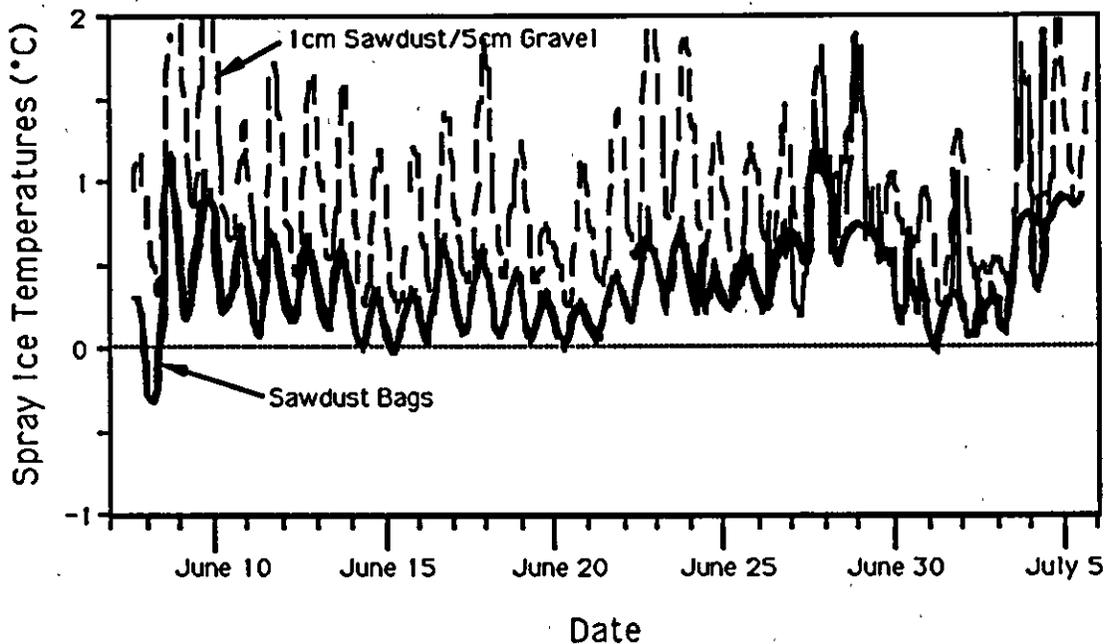
Figure 19. Spray Ice Temperatures Beneath Selected Ablation Plots

Comparisons of spray ice temperatures measured beneath the sawdust ablation subplots are indicated by the temperature - time series plots shown in Figure 19. Again, both the spray ice and air temperatures were averaged on a daily basis. Like the gravel ablation plots, there was a strong correlation between spray ice temperature and ablation. The thicker the sawdust layer, the lower the spray ice temperature, and the less ablation observed. One anomaly was noted in the spray ice temperature data beneath the sawdust bags at the end of June. Meteorological data cannot adequately account for the rise in spray ice temperature observed

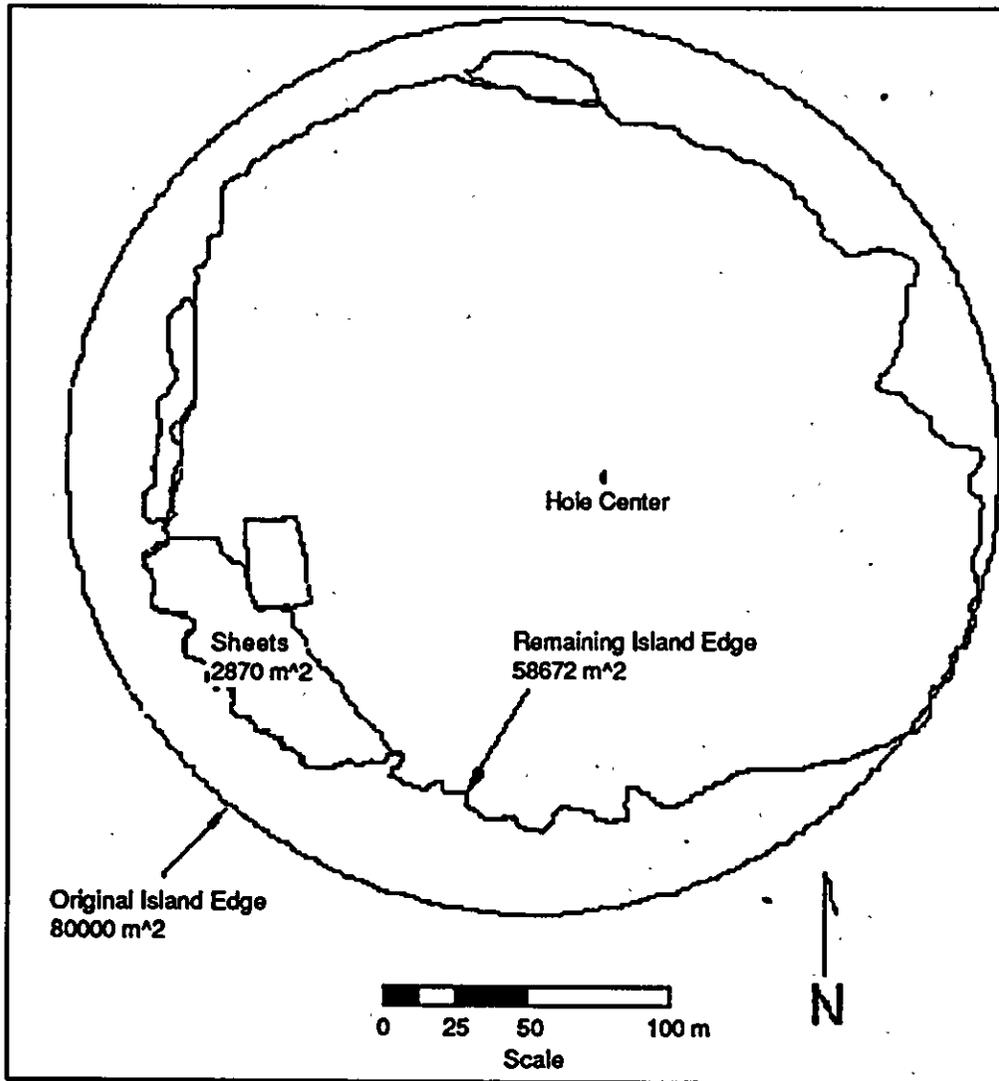
Figure 20. Comparison of Original and Remaining Island Area on July 5

The negative of one color image was analyzed by VTA to determine island area. Using the control points which we provided, a scale factor was computed such that a conversion from the instrument units to true ground units was performed. A perimeter was digitized from which the polygon area was calculated. Three areas were computed: 1) the main ice island excluding the four fragments which appear to have already calved, 2) the area covered by the four fragments, and 3)

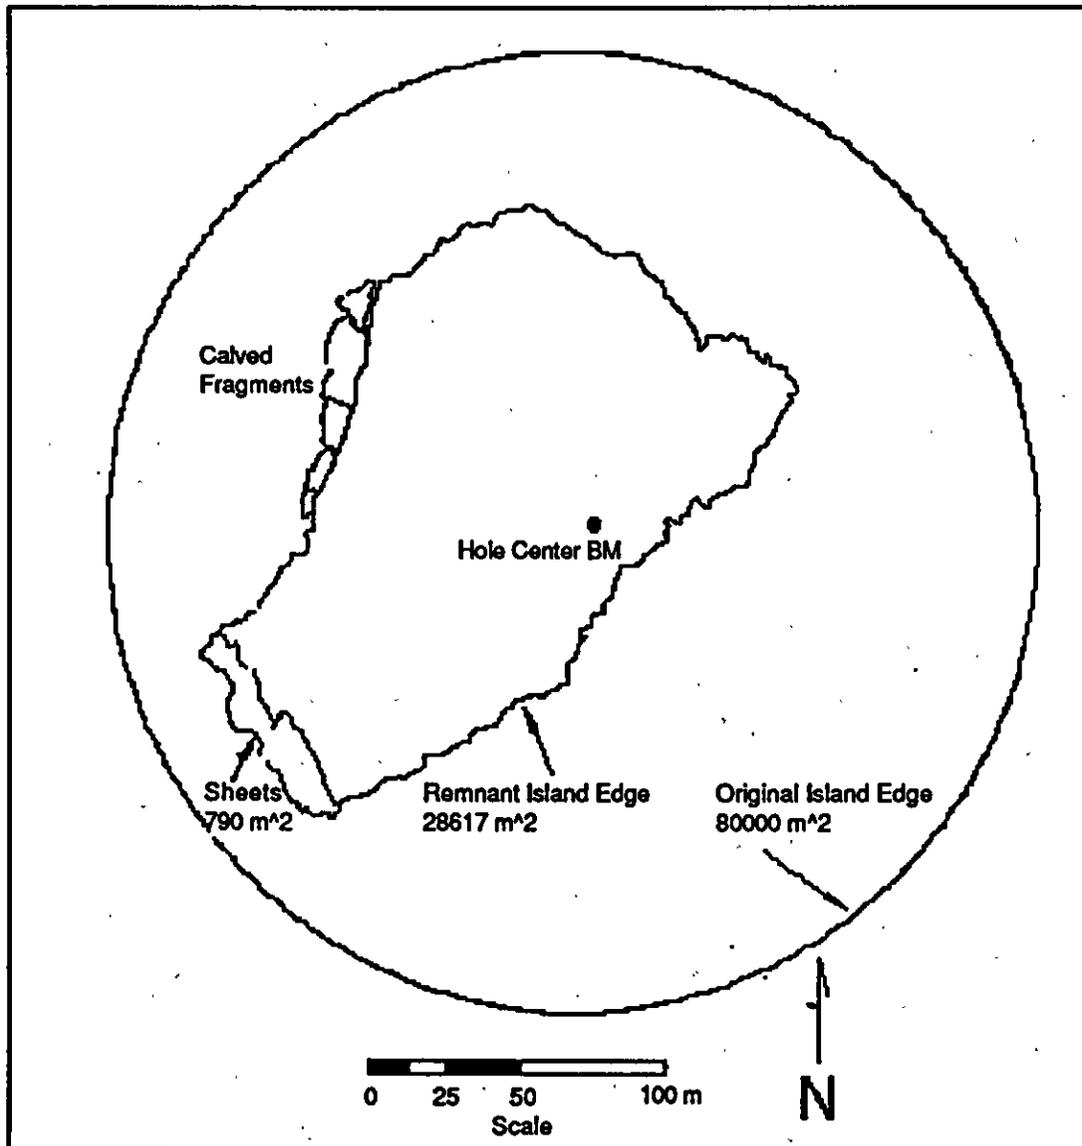
Figure 21. Comparison of Original and Remnant Island Areas on July 8

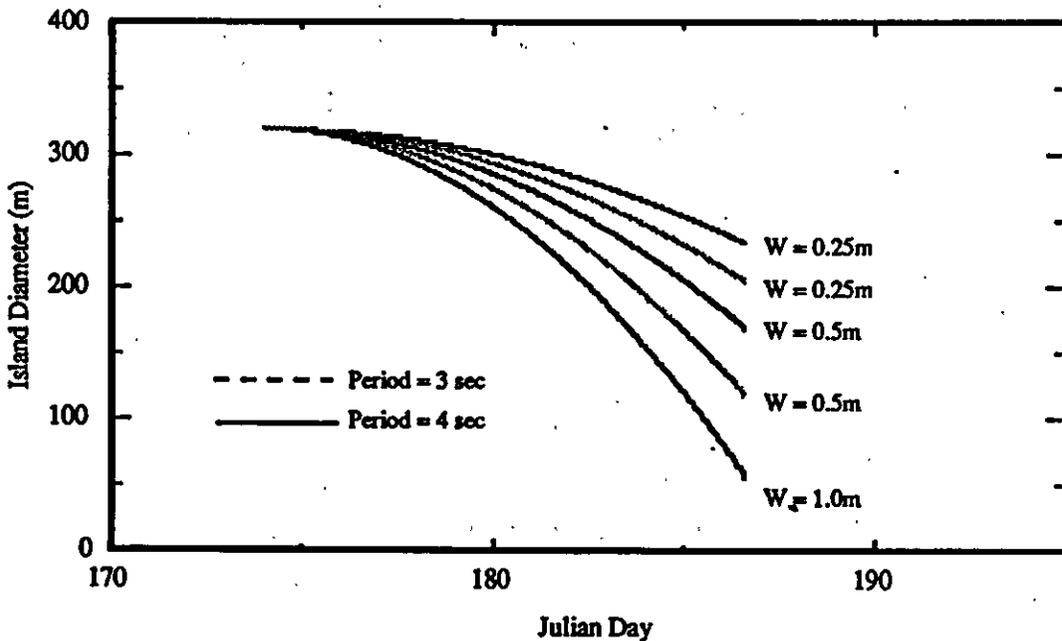
Figure 24. Results of the Use of Different Wave Parameters in the Perimeter Erosion Model.

Wave height, period, and water temperature are important factors in the erosion model. Since data concerning these terms were sparse, a variety of different wave heights and periods were input into the model to determine the sensitivity of the model. The results are shown in Figure 24. Waves of 0.25 m, 0.5 m, and 1.0 m were input along with periods of 3 and 4 seconds. The model was run from the first day of open water, June 23, until July 5.

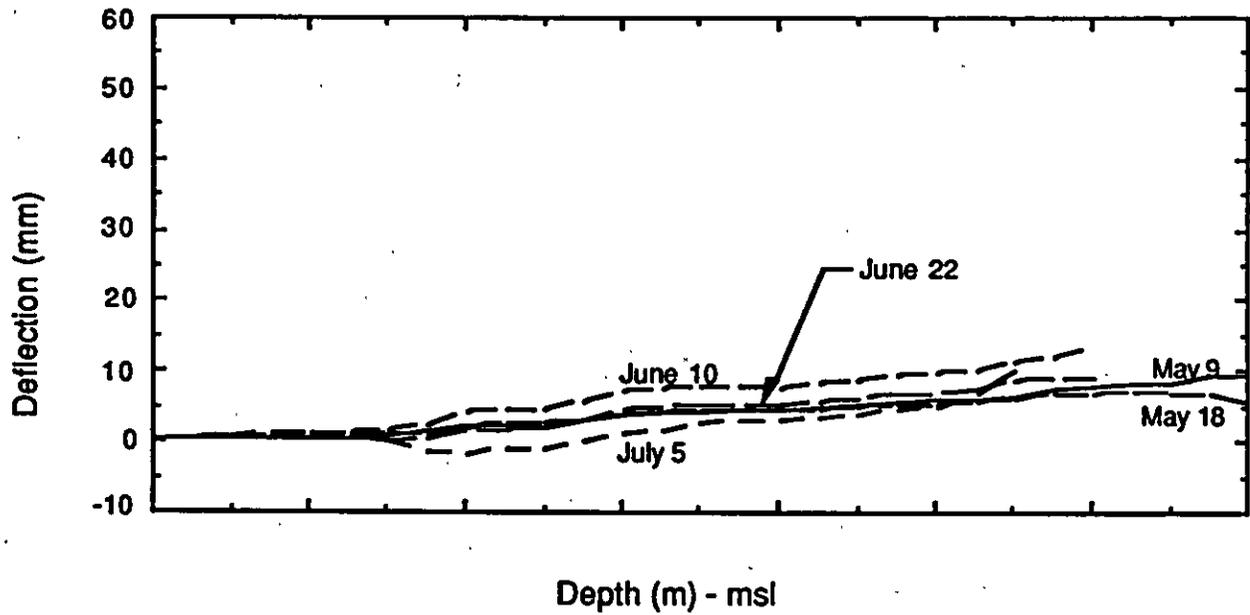
Figure 26. Southwest Slope Indicator Station Deformation Profiles (North-South Direction)
