NIPTERK P-32 SPRAY ICE ISLAND

ABLATION PROTECTION EXPERIMENT

J.P. POPLIN

JANUARY 1990

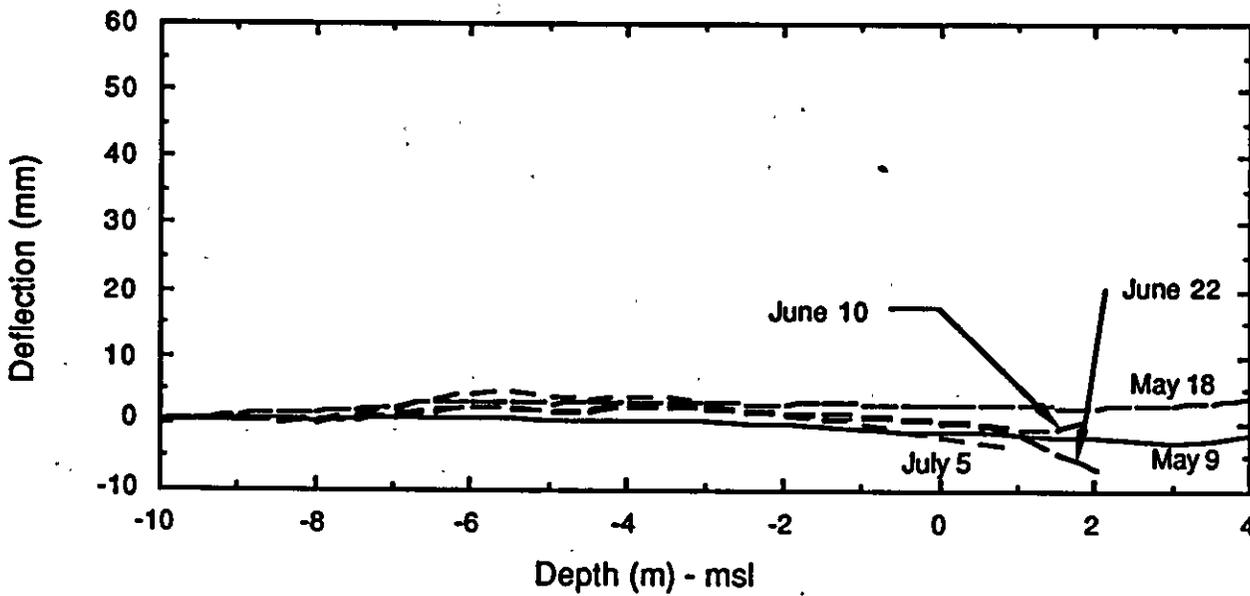
Figure 27. Southwest Slope Indicator Station Deformation Profiles (East-West Direction)

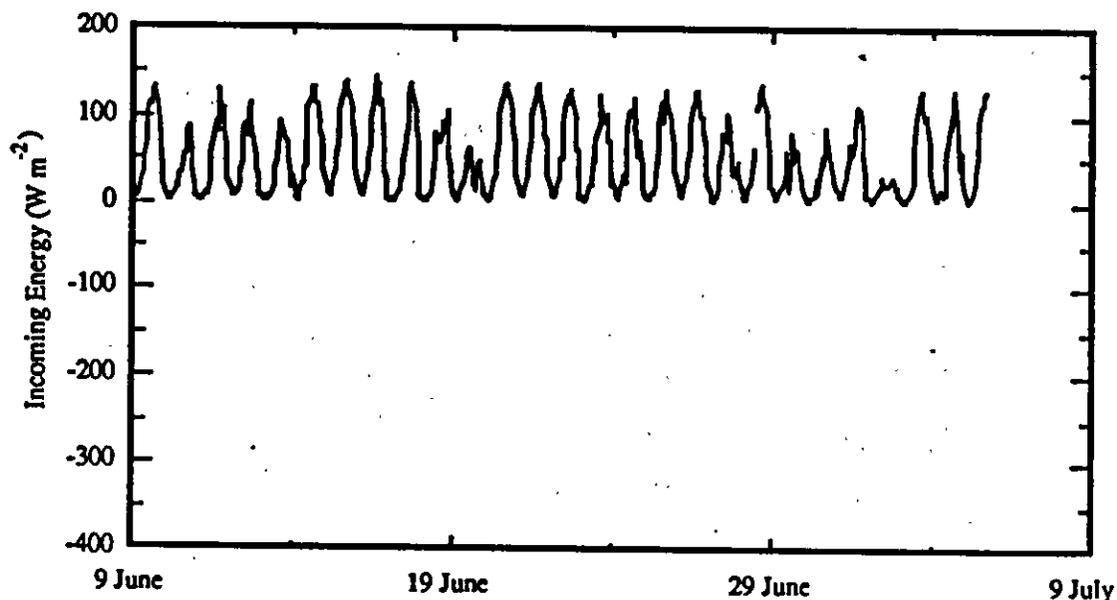
Figure 1. Net solar radiation over ice during the field experiment.

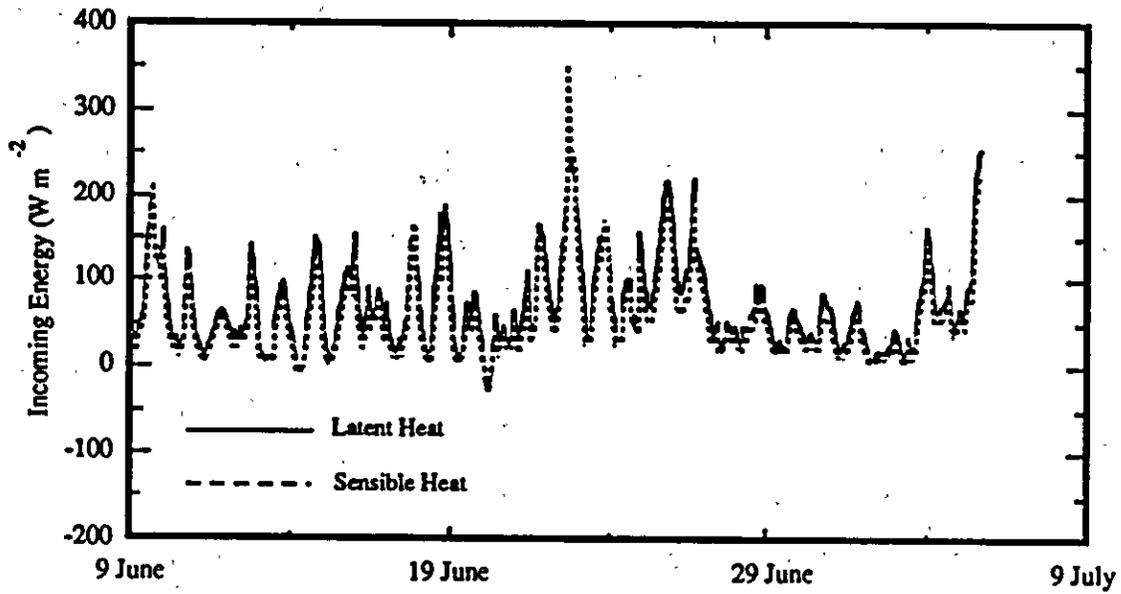
Figure 4. Sensible and latent heat flux off the spray ice.

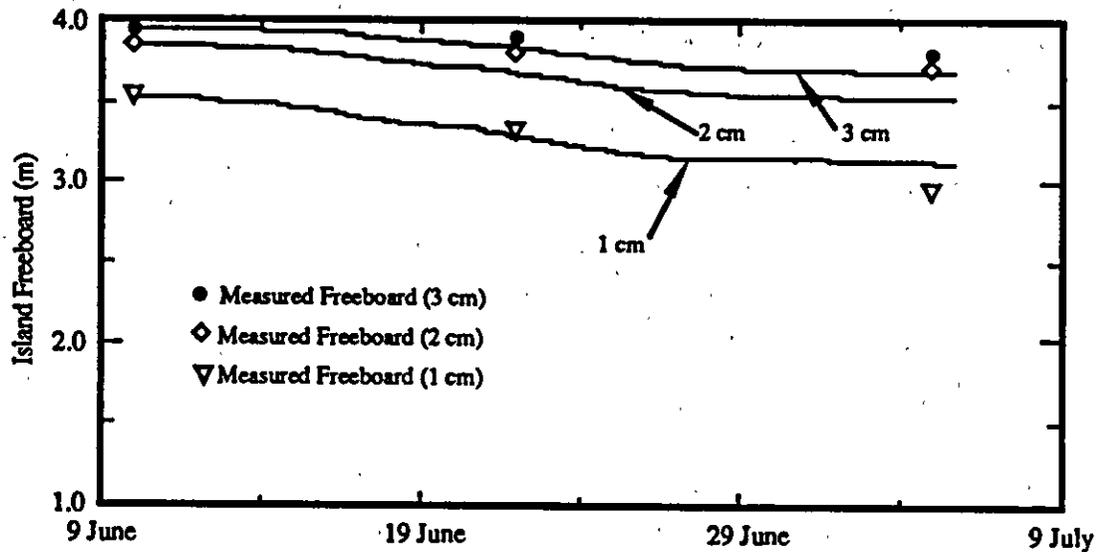
Figure 6. Comparison between measured and modeled ice meltback under sawdust.

A similar situation occurred in the modeling of the ice meltback under gravel as that which was observed with the sawdust. In both cases the model under estimated the meltback under the thinner layers and over estimated the meltback under the thicker layers. Figure 7 shows the meltback under gravel for three different layer thicknesses with the diffusivity of gravel taken to be $1.4 \times 10^{-7} \text{ m}^2 \text{ sec}^{-1}$. Since the surface energy balance terms used for both materials is the same, this may reflect an error

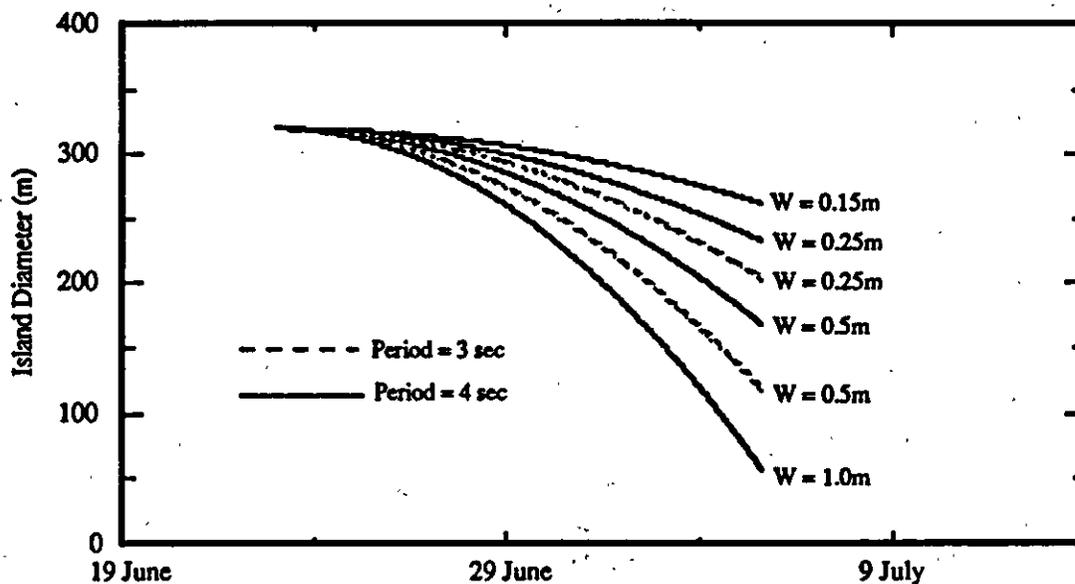
Figure 8. Results of the use of different wave parameters in the perimeter erosion model.

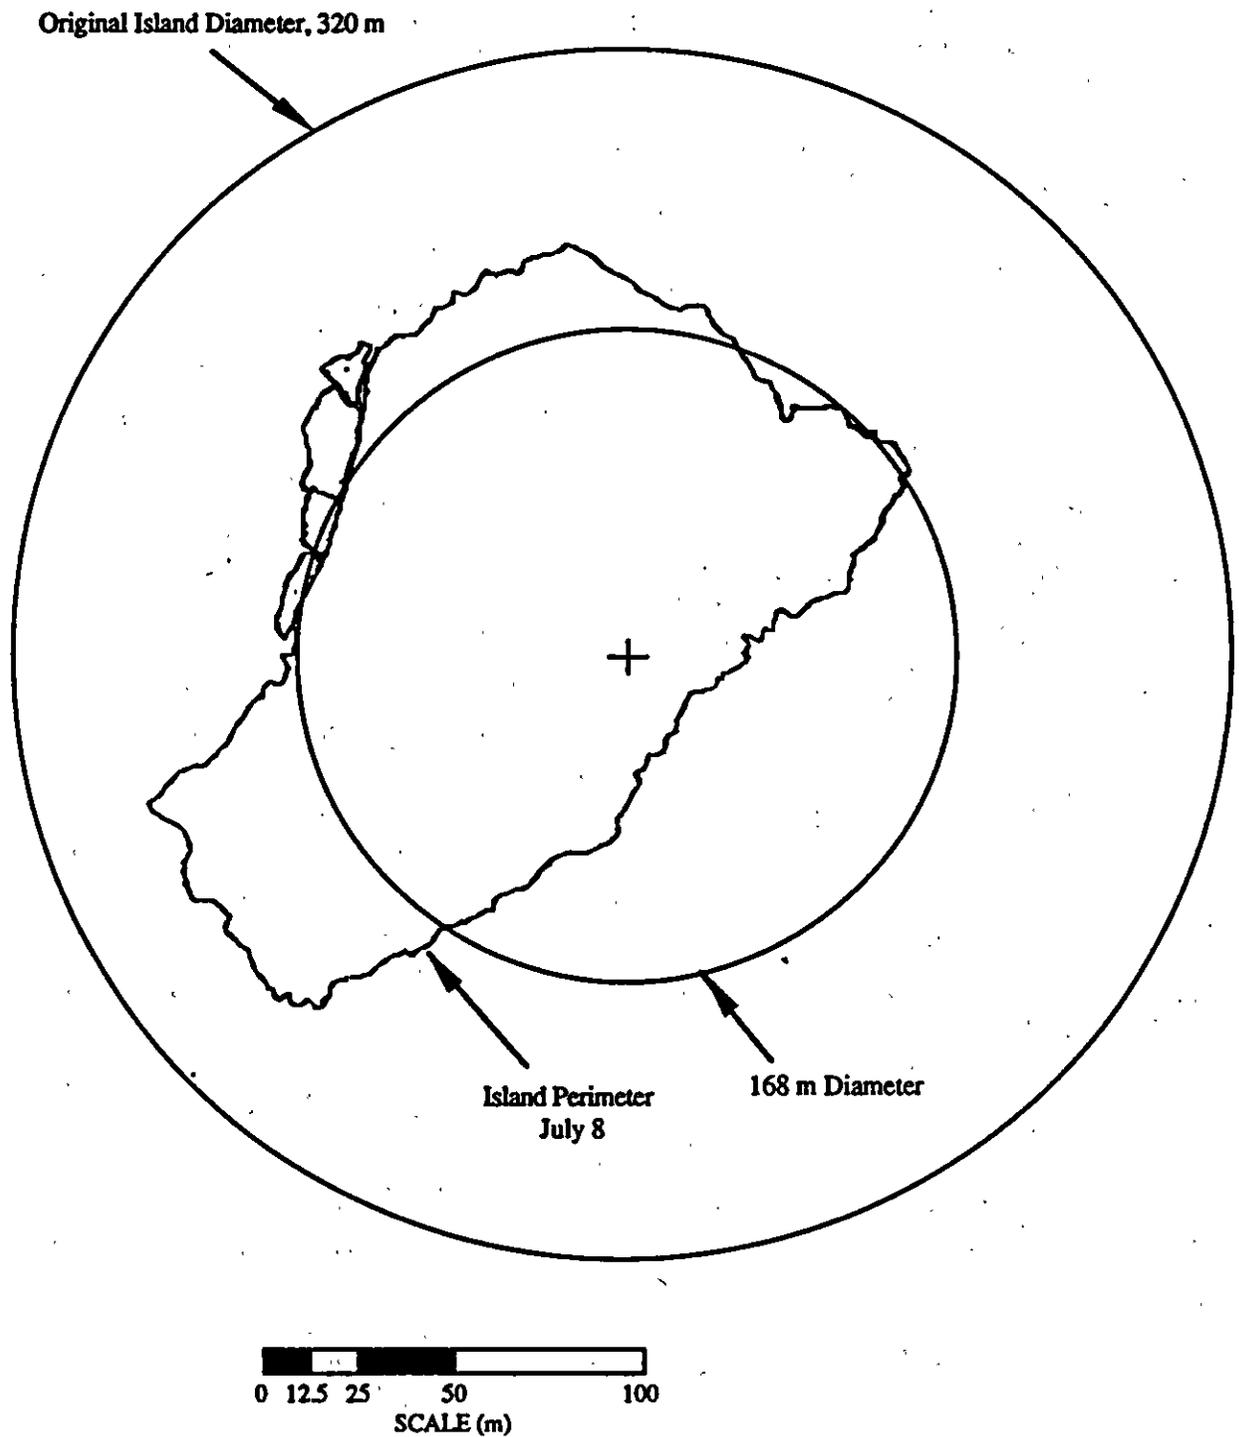
Figure 9. Aerial view of island showing measured perimeter and model results of 8 July.

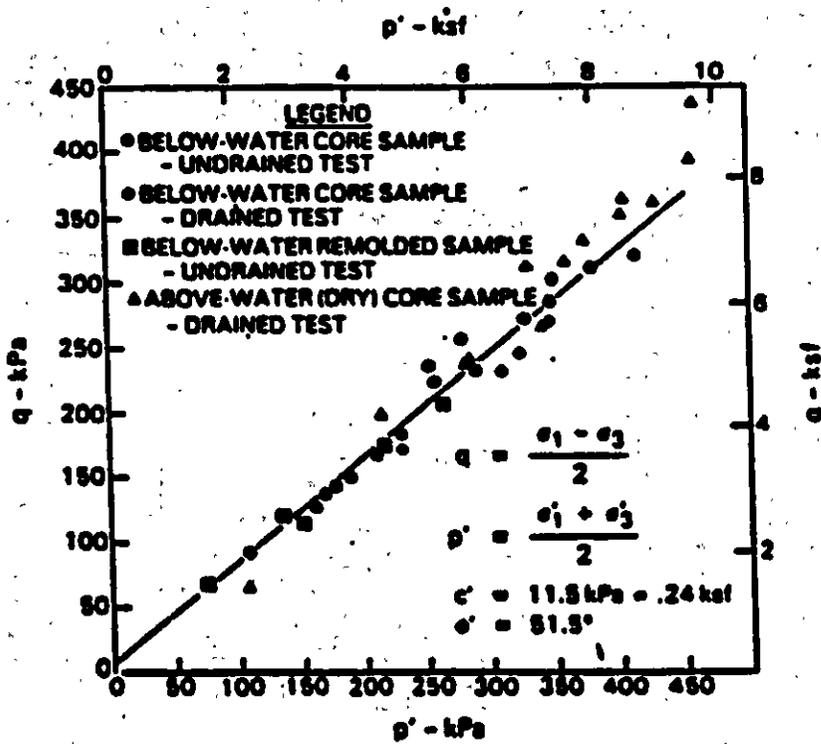
FIGURE 2. Effective stress state at failure. This figure is reproduced from the paper by Chen and Gram, (reference 3)

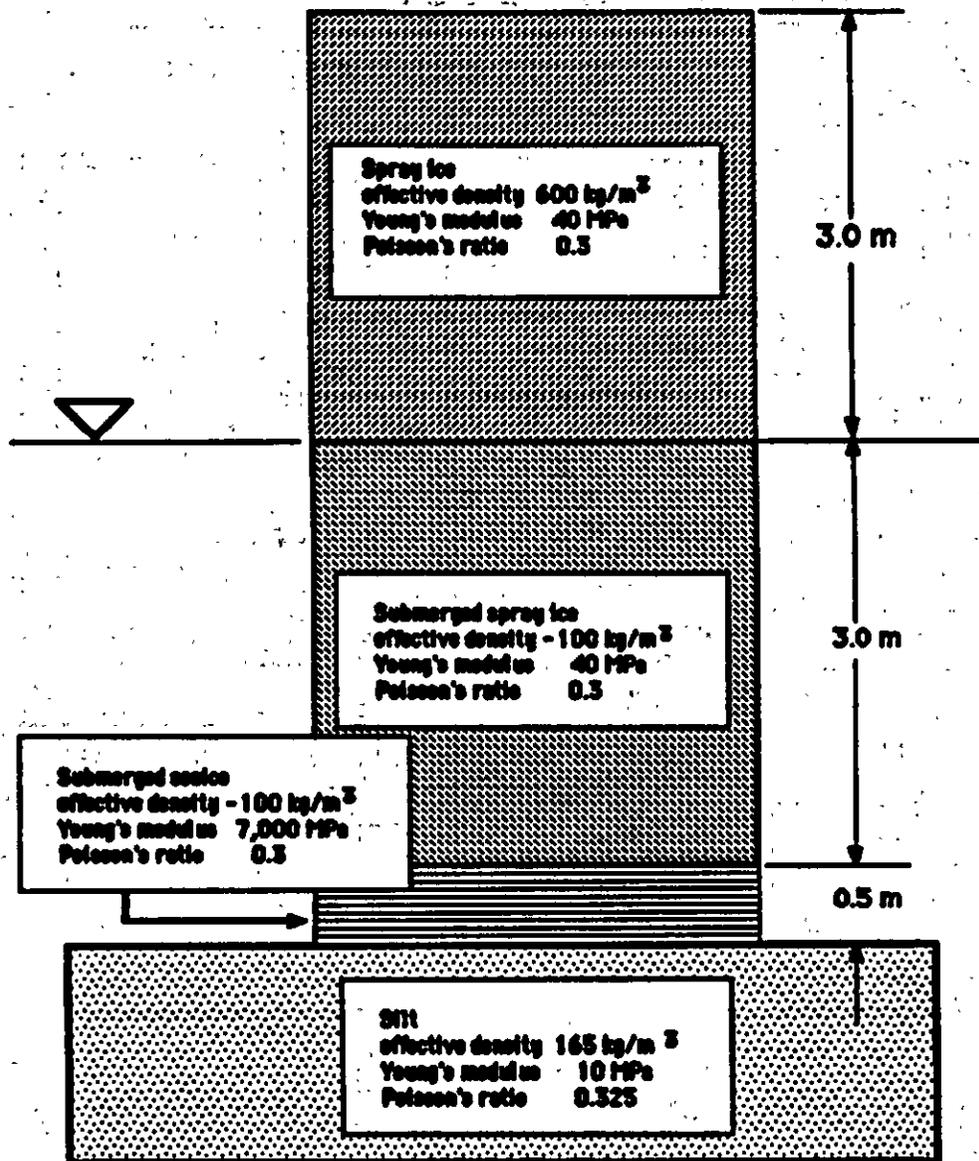
FIGURE 3. Material model used for finite element stress analysis

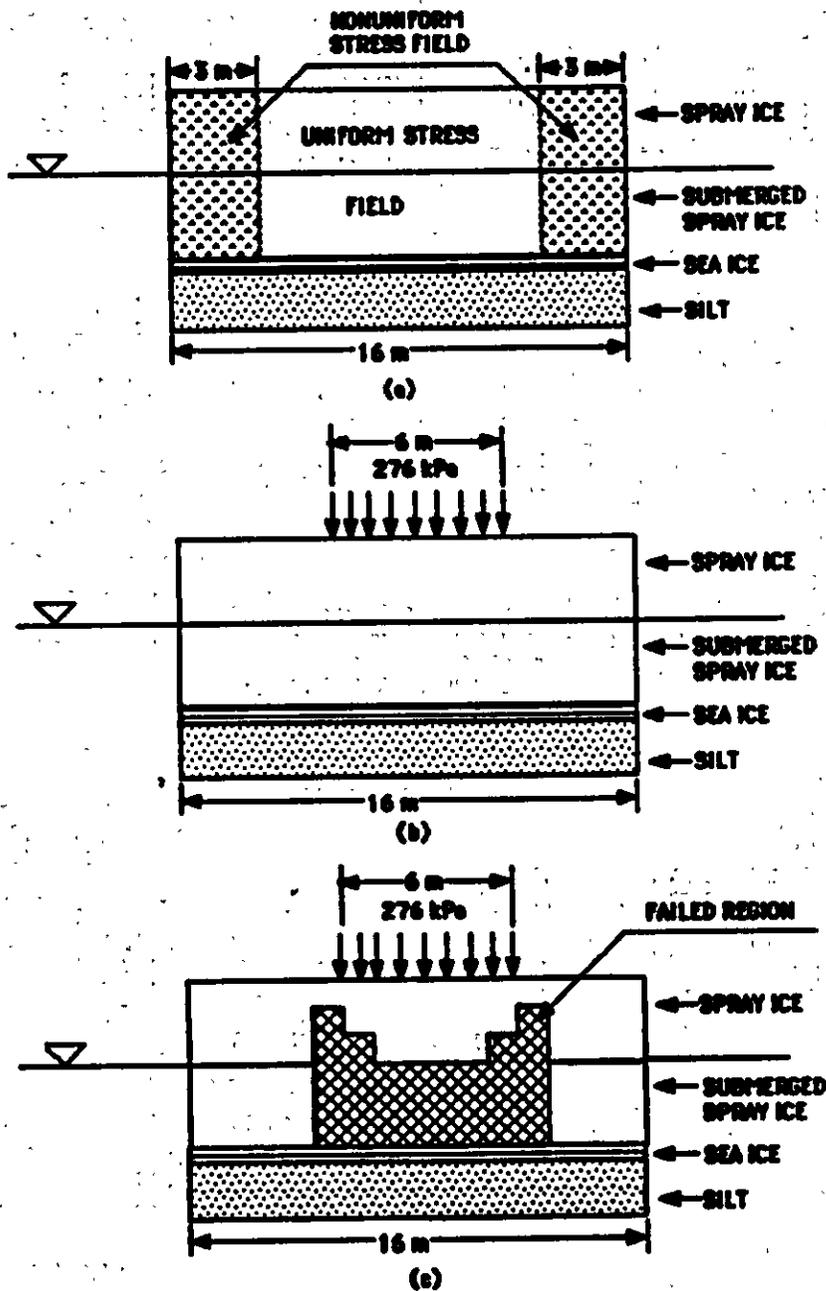
FIGURE 4. Results of stress analysis for different loading configurations, (a) stress field due to body force alone, (b) geometry of a 276 kPa load applied over a 6 m region, (c) region of failed spray ice using Chen/Gram failure envelope.

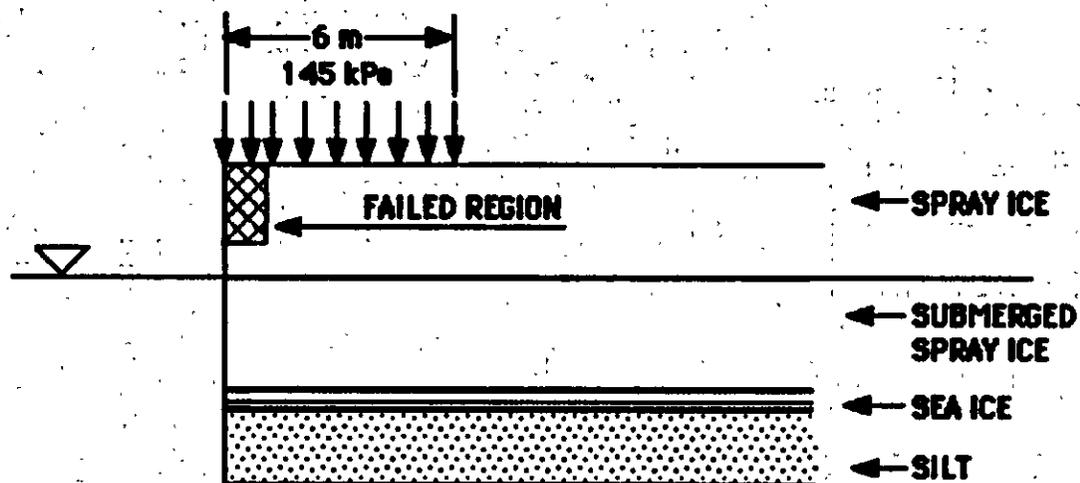
FIGURE 5. Failure threshold when the load is moved to the edge of the spray ice. In this instance failure occurred when the ground pressure was raised to 145 kPa.
