**JIP - STRENGTHENING, MODIFICATION AND  
REPAIR TECHNIQUES FOR OFFSHORE PLATFORMS**

**DEMONSTRATION TRIALS OF DIVERLESS  
STRENGTHENING AND REPAIR TECHNIQUES**

**FINAL REPORT**

**DOC REF C15800R025 Rev 1 SEPTEMBER 1997**

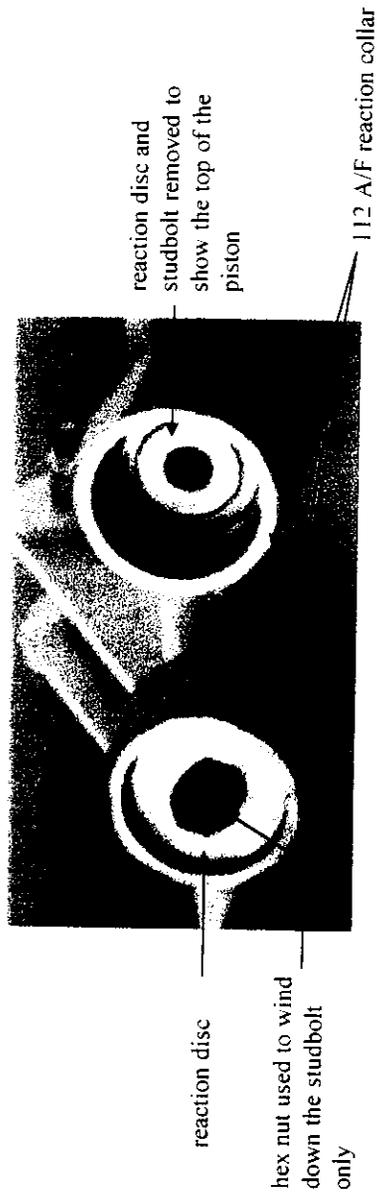
**Figure 6.12: Diverless Studbolt Tensioning System**

**STAGE 3**  
The hydraulic pressure is maintained while the collar is wound upwards into firm contact with the reaction disc.

**STAGE 4**  
The hydraulic pressure is released locking in the studbolt tension via the body of the hydraulic nut

The tensioning solution and its operation is illustrated in Figure 6.12. The system works by applying hydraulic pressure beneath the piston which is pushed upwards to bear against the reaction disc, threaded onto the studbolt. Suitable hydraulic pressure is applied to stretch the studbolt to the desired preload. While the pressure is maintained, the external collar is wound upwards to bring it into firm contact with the reaction disc. Hydraulic pressure is removed and the studbolt tension is carried through the collar into the body of the tensioner and into the clamp flange plate.

hydraulic bolt tensioner fixed to flange (refer to Figure 6.12)
