**2010 Freeze-Up Study of the Alaskan Beaufort and Chukchi Seas**

**Progress Report No. 1  
October 1, 2010 – April 1, 2011**

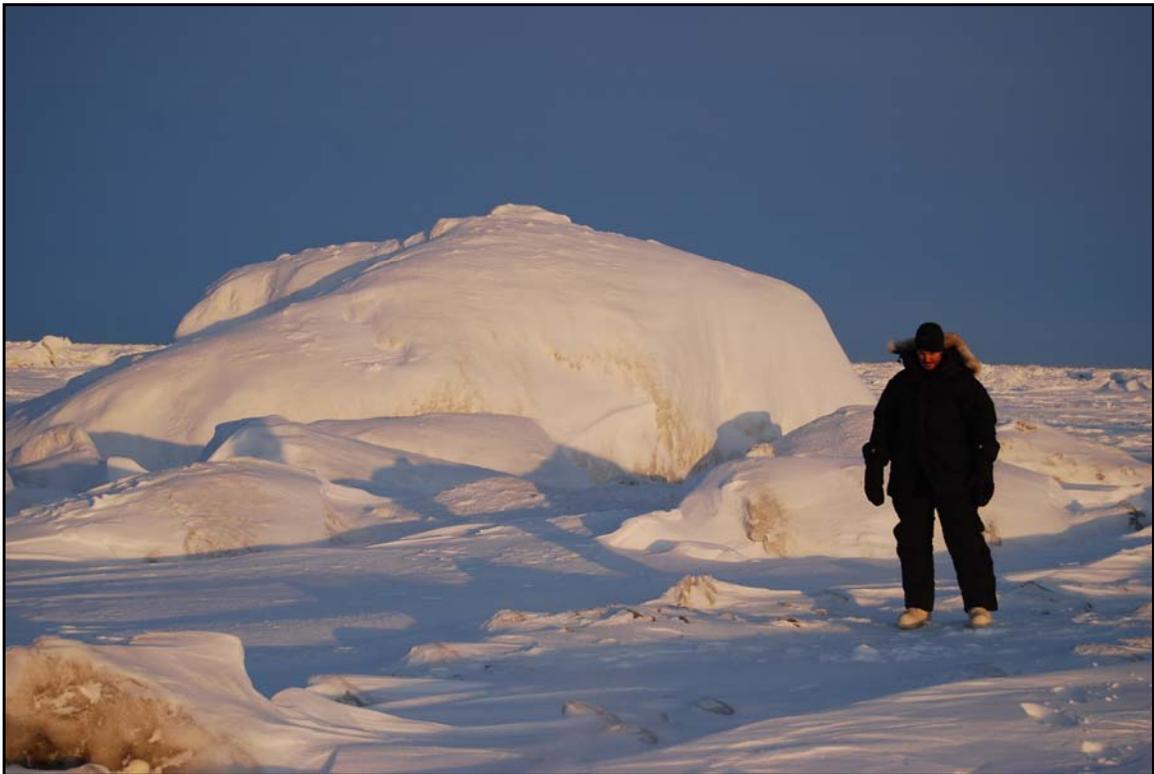
encroach onto the work surface. Although pile-ups were absent from the natural barrier islands, grounded ice rubble typically covered between 20 and 50% of the north-facing island shorelines. The rubble appeared to have formed offshore and then been driven onto the beaches. The largest pieces, with heights up to 5.5 m, were found on Cross Island (Plate 1).

**Plate 1. 5.5-m Grounded Rubble on North Shore of Cross Is. (3 February 2011)**
