Society of Naval Architects & Marine Engineers
Northern California Section
Student Paper Presentation
April 9, 1992

The Grounding of *Exxon Valdez*: An Examination of the Human and Organizational Factors

by
William H. Moore, Student Member
Department of Naval Architecture & Offshore Engineering
University of California at Berkeley

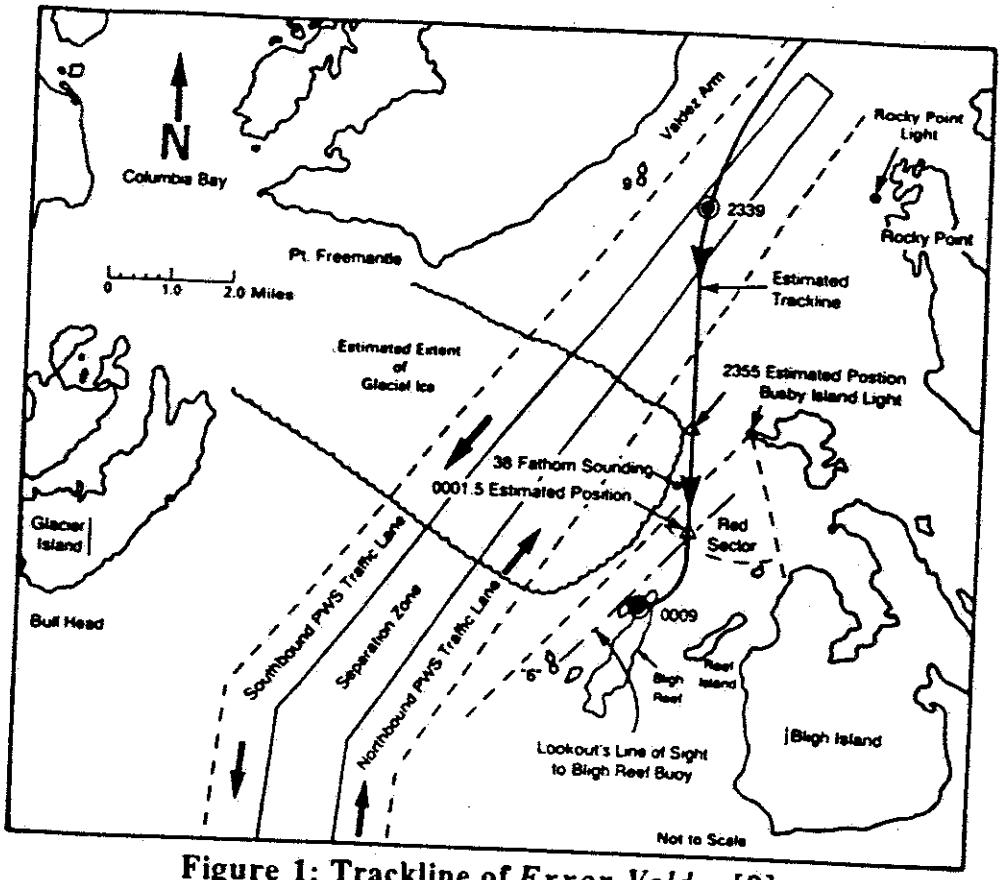
At 2347 the ship left the Traffic Separation Scheme (TSS) going into the inbound lane to avoid the ice. At 2355 the helmsman was relieved by Robert Kagan [6]. The NTSB has simulated the path which *Exxon Valdez* traveled once deviating from the TSS and is

shown in Figure 1. The ship was on "load program up" which meant she was increasing her speed while exiting the harbor. Thus, *Exxon Valdez* was traveling at 12 knots and on automatic pilot just prior to hitting Bligh Reef. Putting the ship on automatic pilot in confined waters and not telling the third mate the master had done so was extremely inconsistent with normal practice. At his relief at 2350, the helmsman reported to the third mate that the ship was on automatic pilot, something the third mate did not know about (there is some speculation that the ship was operating on automatic pilot until the grounding). The third mate did not discuss the reason for the automatic pilot with the master.

Figure 1: Trackline of *Exxon Valdez* [9]

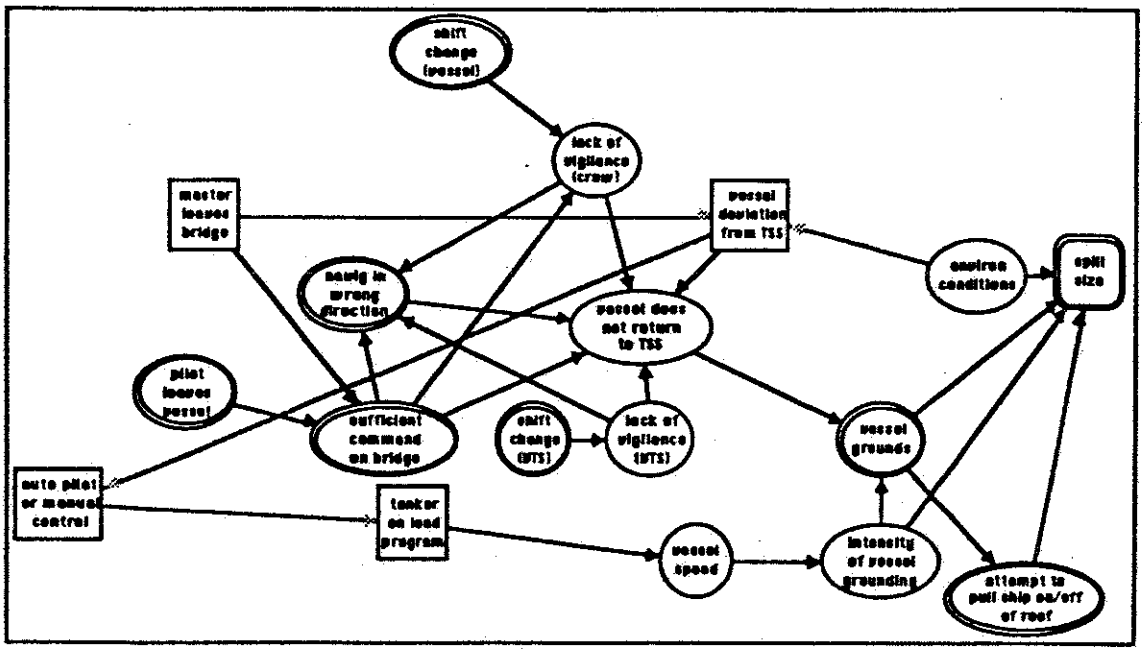
The model represent the set of events that occurred aboard the *Exxon Valdez*, the vessel transit in and out of the TSS, and at VTC in Valdez. Figure 2 summarizes the dependency of events, direct causes and decisions involved in the grounding discussed above. These influences are represented by nodes, (events, causes, and decisions) and arcs which establish the dependencies. Probabilities are represented by oval nodes, deterministic events are represented by double-lined oval nodes, decisions are represented by rectangular nodes, and expected returns are represented by double-lined rectangular nodes. The development of influence diagram models should be the effort of a group of experts. Discussion of differences in opinion of the relationships of between events and their causes illicit the development of more realistic models [14].

Figure 2: Influence of events and decisions leading to the grounding of *Exxon Valdez*

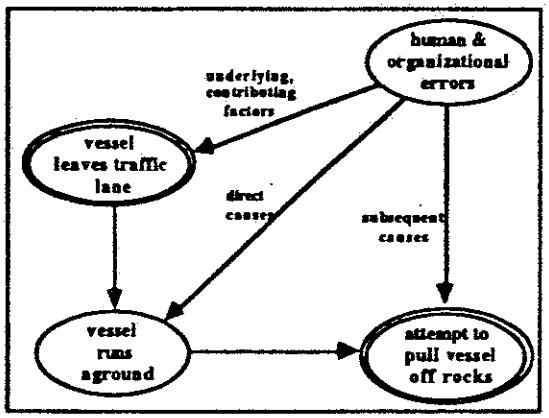
Figure 3: Influence of HOE on sequence of grounding events

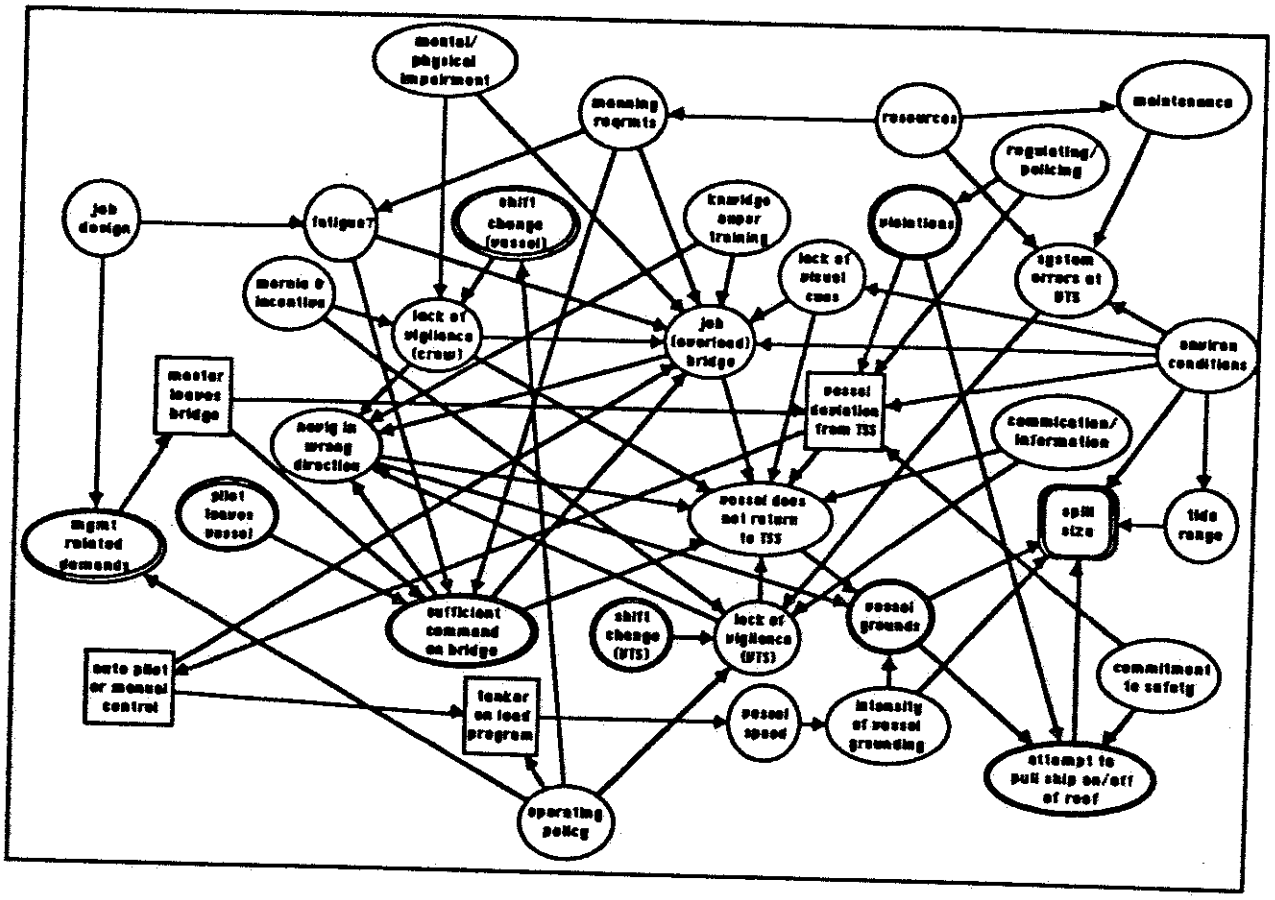
The *Annotated Human Factors Taxonomy* (AHFT), soon to be used by U.S. Coast Guard marine casualty investigators, form the basis for the U.C. Berkeley HOE project taxonomy. The AHFT distinguishes underlying, direct, and compounding causes to marine casualty events as exemplified in Figure 3. Additional sources are used to examine *violations*, *commitment to safety*, and *resources*. The influence of causes upon the decisions and events specific to *Exxon Valdez* are shown in Figure 4.

Figure 4: Influence of HOE causes on the grounding of *Exxon Valdez*

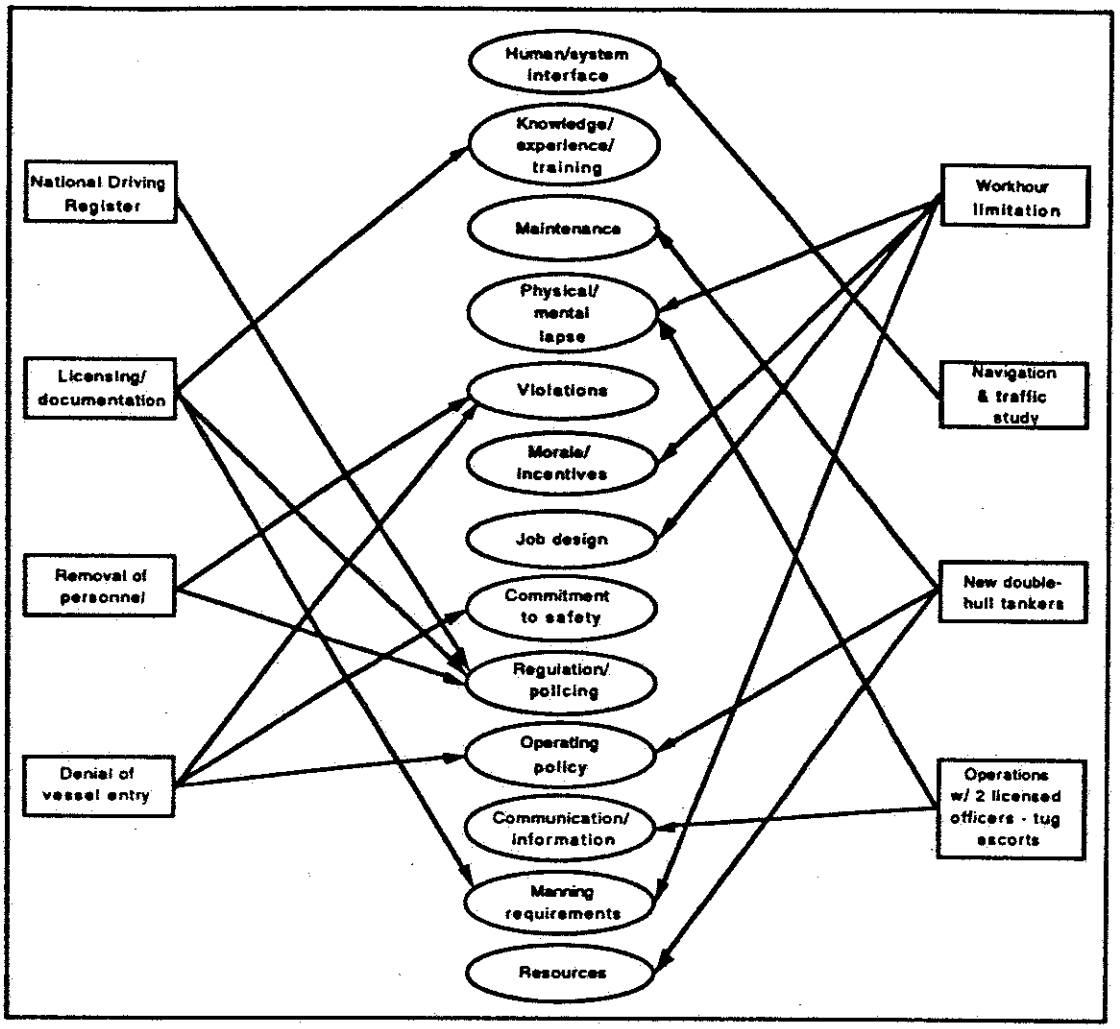
Figure 5: Influences of Oil Pollution Act of 1990 on HOE related accident causes

The influence diagram frameworks in Figure 4 can be used to determine the effectiveness HOE related management alternatives of OPA 90 on the overall failure probabilities of the system. Figure 5 summarizes the influences of OPA 90 on the various contributing causes of marine related accidents discussed above. The importance in evaluating are to determine their effectiveness in reducing the overall failure probability of this class of grounding accidents. For example, when legislating OPA 90, was the reduction of cargo capacity of double-hull tankers resulting in more tanker traffic to maintain capacities taken into account [15]? The additional traffic could increase the risk of other classes of accidents such as collisions. It is imperative that these issues are addressed in the PRA analyses framework.
