# Investigation of H<sub>2</sub>S Gas Release Platform Hermosa, OCS-P 0316 Pacific OCS Region

August 3, 1999

U.S. Department of the Interior  
Minerals Management Service  
Pacific OCS Region

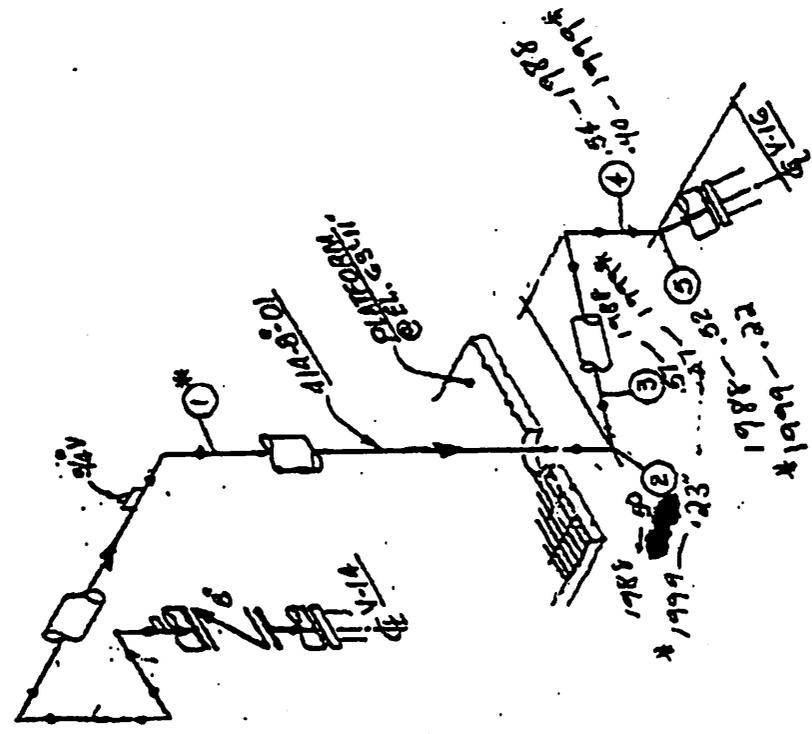
5 TEST POINTS.  
\* 1 HOLES TO BE CUT IN INSULATION.
