## EROSIONAL/CORROSIONAL TESTING FOR MULTIPHASE FLOW LINES

FINAL REPORT  
SwRI Project No. 04-6461

For  
Minerals Management Service  
U.S. Department of the Interior  
Reston, Virginia

April 1995

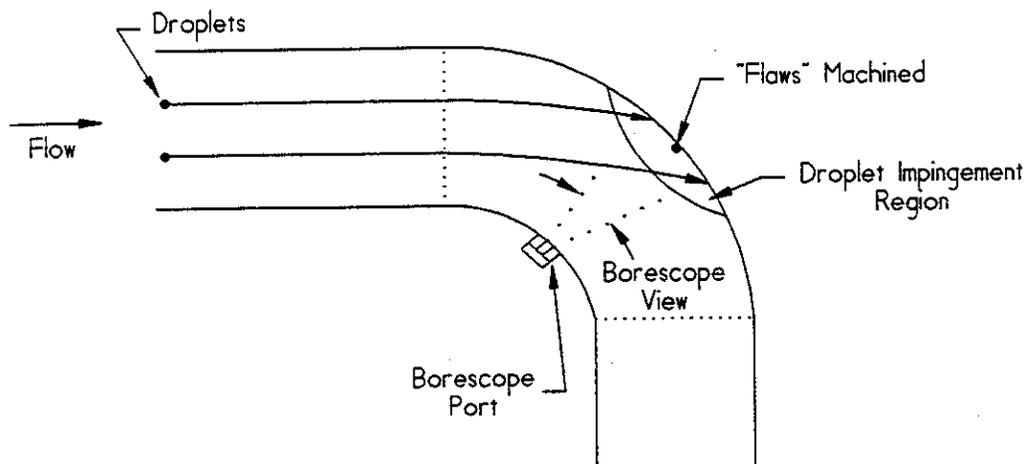
**Figure 3.4. Drawing Showing the Region Photographed by the Borescope.**

Localized pitting wear was determined in two ways. The first method was to inspect and photograph the inside surface of the elbow during the test with a borescope. The borescope was inserted through a fitting welded to the elbow as shown in Figure 3.4. The borescope could only view a limited portion of the elbow inside surface, but its position was selected to view the region where pits were most likely to form. The photographs taken during the test were used to know when to stop the test and to determine if pit growth were steady, or if some incubation time were needed to start pit growth. Figure 3.5 shows photographs taken with the borescope during Test 5. The photographs show the pit growth from day 21 to day 31. The small objects are the three flaws that were machined into the elbow prior to starting the test.
